## ***2021 ROUTINE BRIDGE SAFETY INSPECTION REPORT***

Cleveland Township, Columbia County  
T-356 (Shakespeare Road) over Roaring Creek  
County Bridge No. 12  
BMS No. 19-7205-0356-0012  
BRKEY: 12785

March 24, 2021  
C1  
12 Months  
Dale J. Sitler, P.E., C.B.S.I.  
and  
Andrew J. Susen, C.B.S.I.

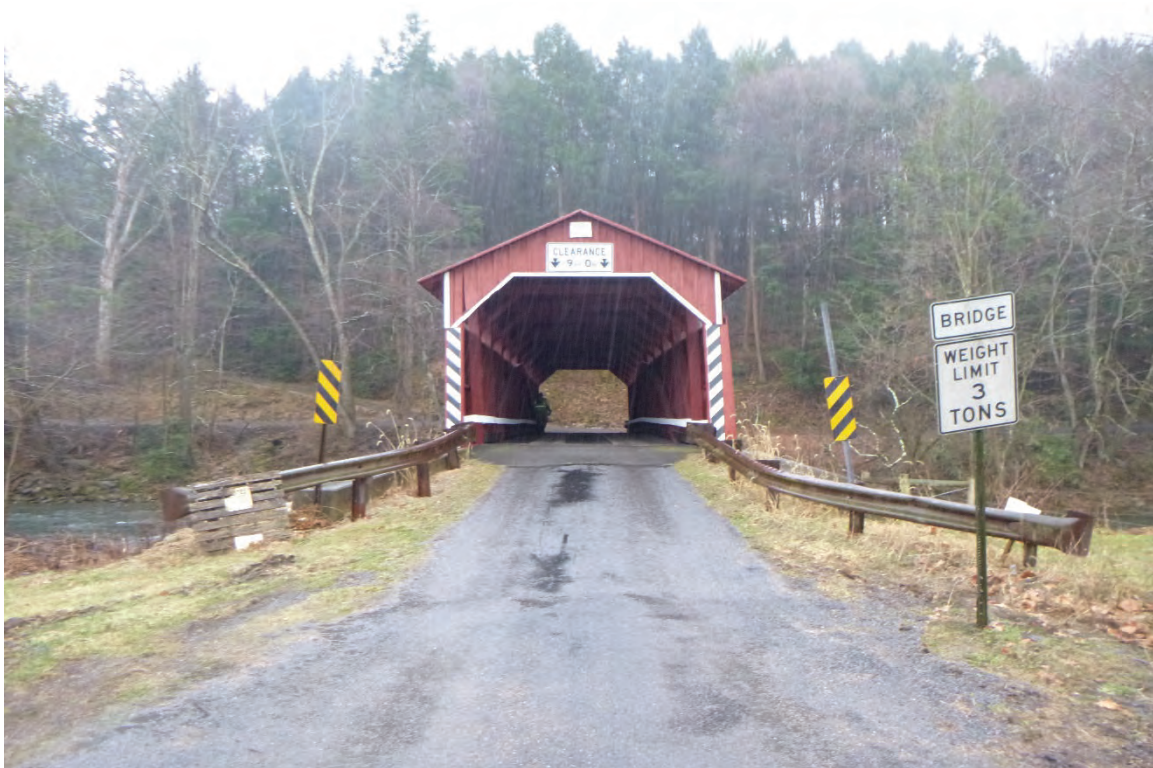
FAR APPROACH

The far One Lane Bridge Sign is missing. All other required signing is present and is clearly legible.

Note: One Lane Bridge sign is missing.

Replace the missing One Lane Bridge sign at the far approach.

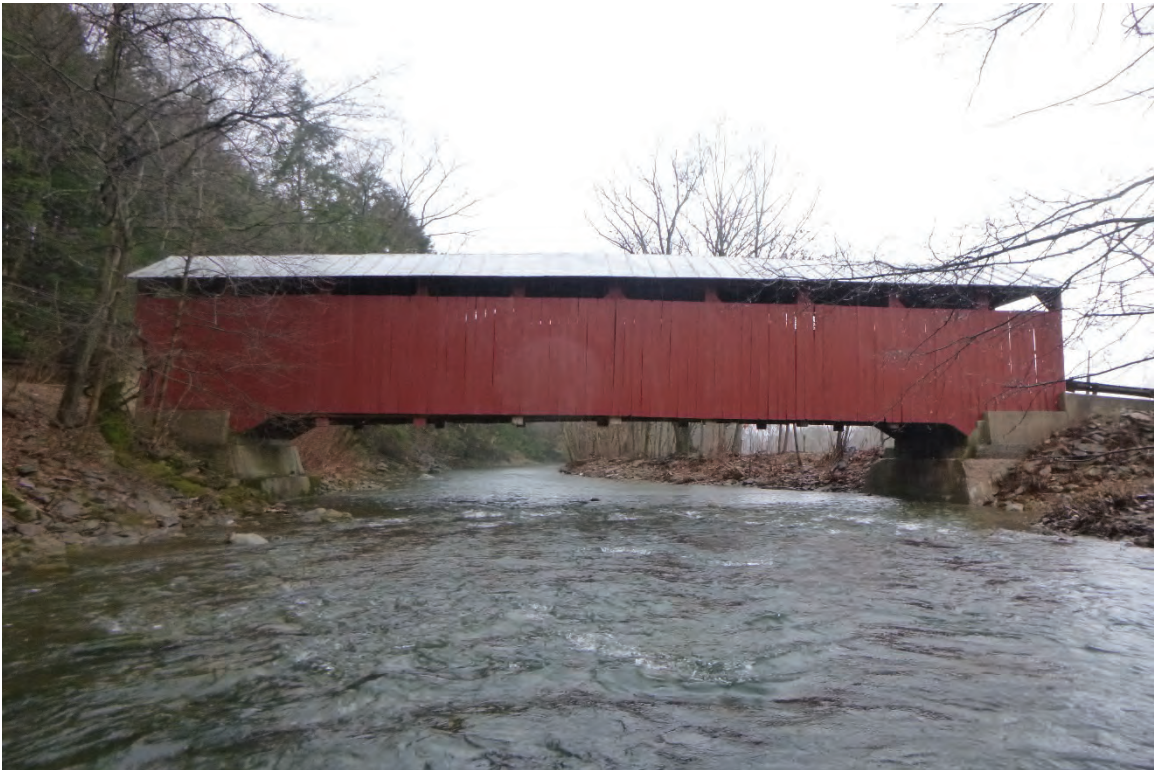
INLET ELEVATION

Note: Structure was painted since the 2018 inspection.

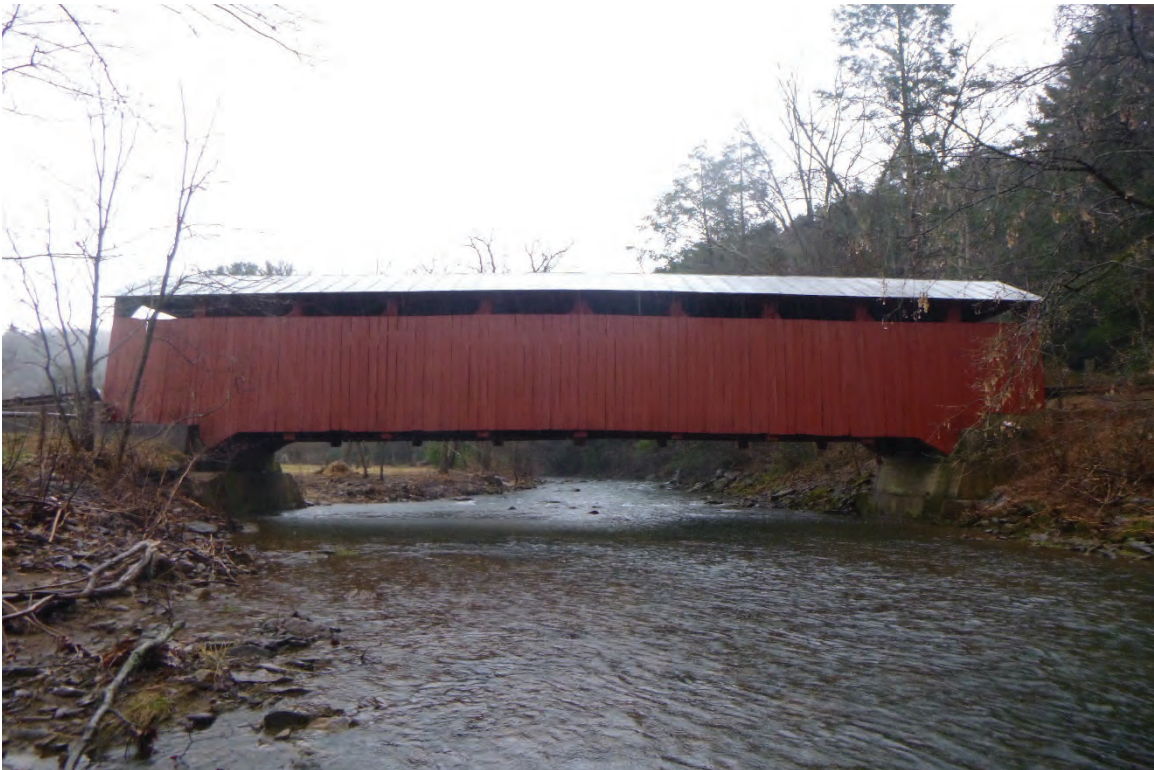
OUTLET ELEVATION

Note: Structure was painted since the 2018 inspection.

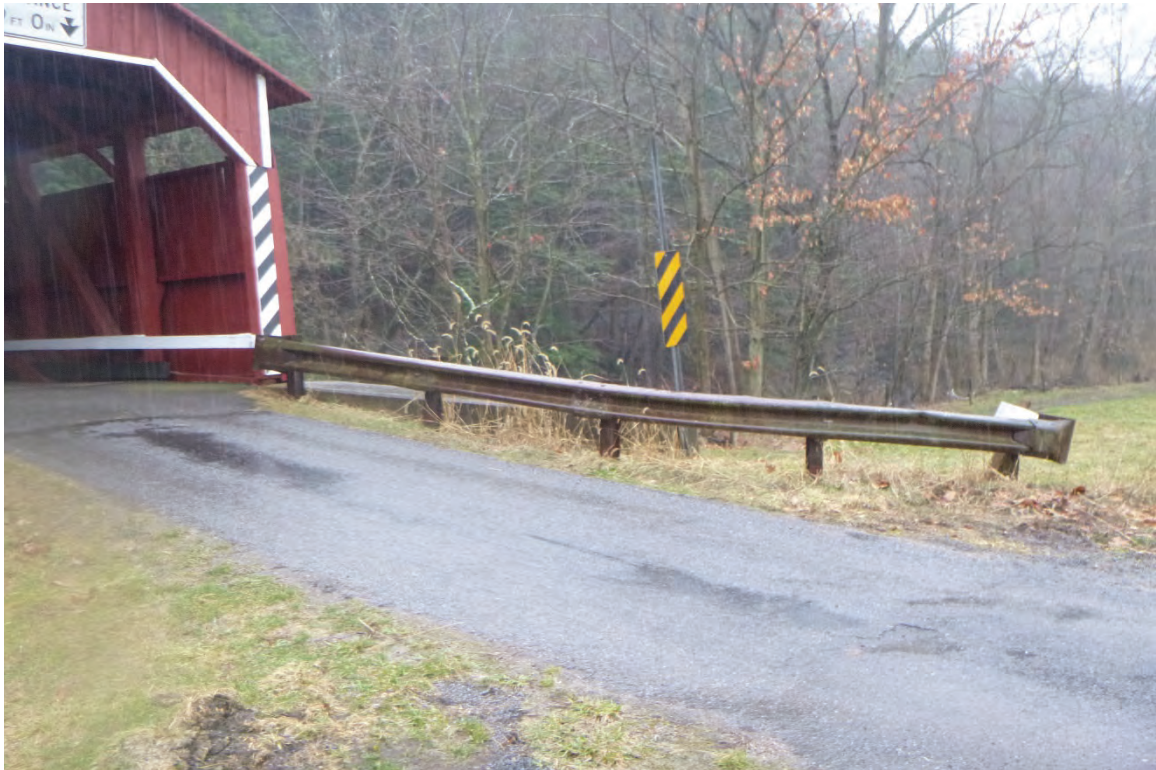
TYPICAL GUIDE RAIL

near right and one post at the far left are disconnected, and the first two posts adjacent to the timber railing at the near left and near right have no offset brackets. The approach guide rail requires repair due to the disconnected posts at the near right and far left.

Note: Far left shown. Guide rail not attached to the structure.

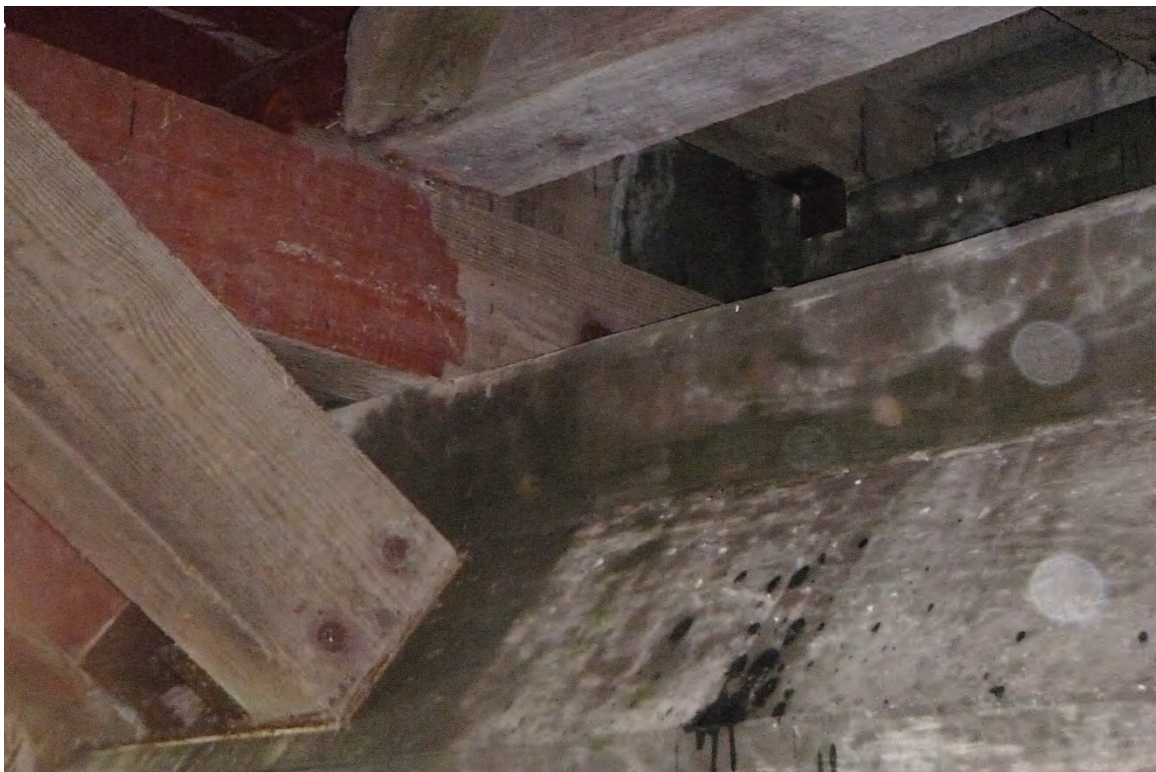
TYPICAL BEARING

The neoprene bearing pads under the low chords exhibit no defects. The steel arch bearing shoes exhibit minor spot rust and are stable. The stringer bearings at the near abutment consist of timber shims and steel angle clips. The stringers at the far abutment bear only on the end floorbeam and are cantilevered to the backwall. The far stringer seats exhibit no defects.

Note: Near left shown.

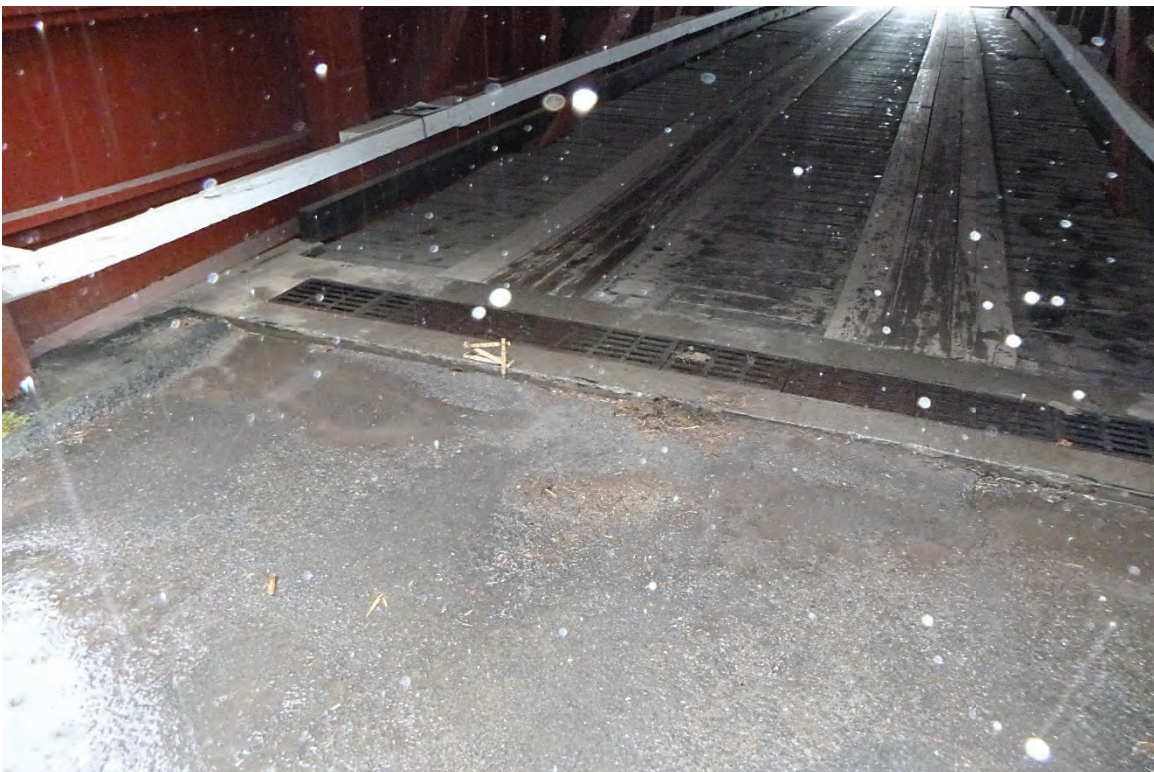
The near bituminous approach roadway exhibits minor gravel deposits. There is 2 1/2" of maximum settlement along the near backwall. The bituminous exhibits minor wear with shallow depressions. The far approach exhibits 1 1/4" of maximum settlement along the backwall and a full width open transverse joint approximately 10' from the structure.

SETTLEMENT AT NEAR APPROACH ROADWAY

Note: No change in settlement. Bituminous curbs are settled and do not direct drainage to the trench drain.

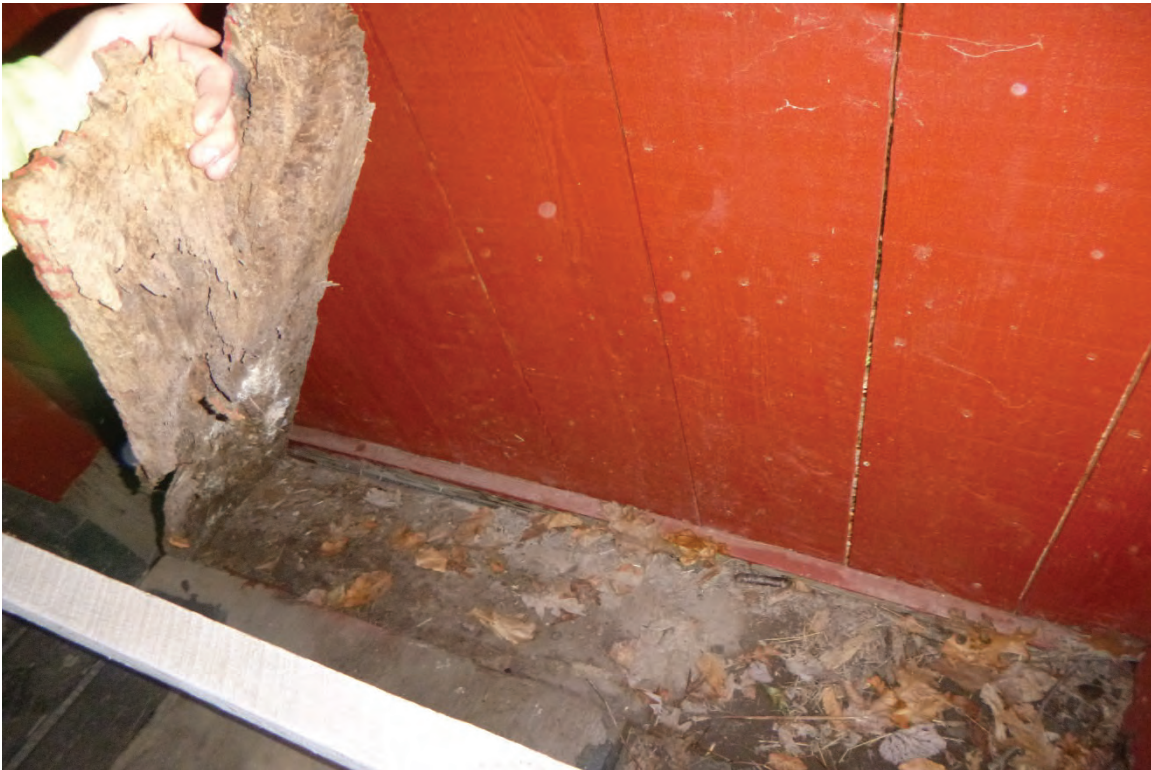
DECAY IN NEAR RIGHT SILL PLATE

Note: No increase since 2019 inspection. Sill set in place during inspection.

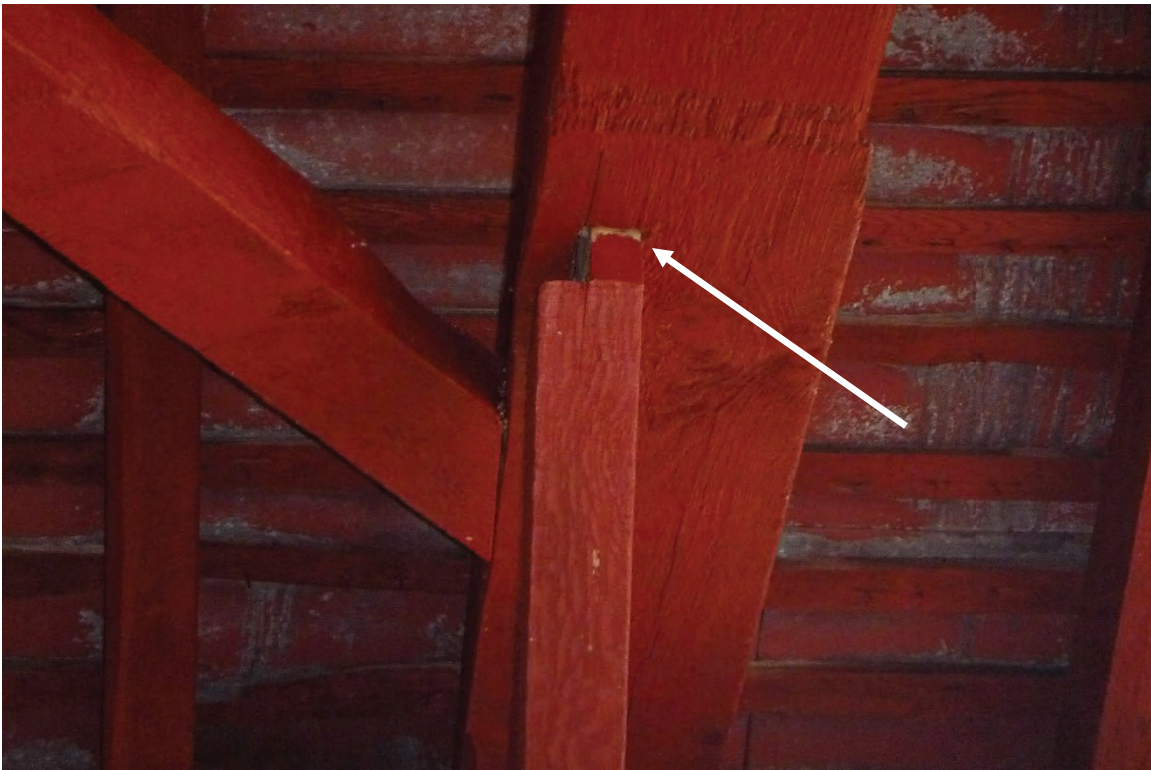
There is a missing longitudinal knee brace at L5 on the left truss. The knee brace at U7 left is missing a dowel at the bottom connection and U8 left is missing a dowel at the top. The knee braces are loose. There is minor decay at a few of the lower diagonal and vertical connections.

LOOSE KNEE BRACE AT U8 LEFT

Note: No change.

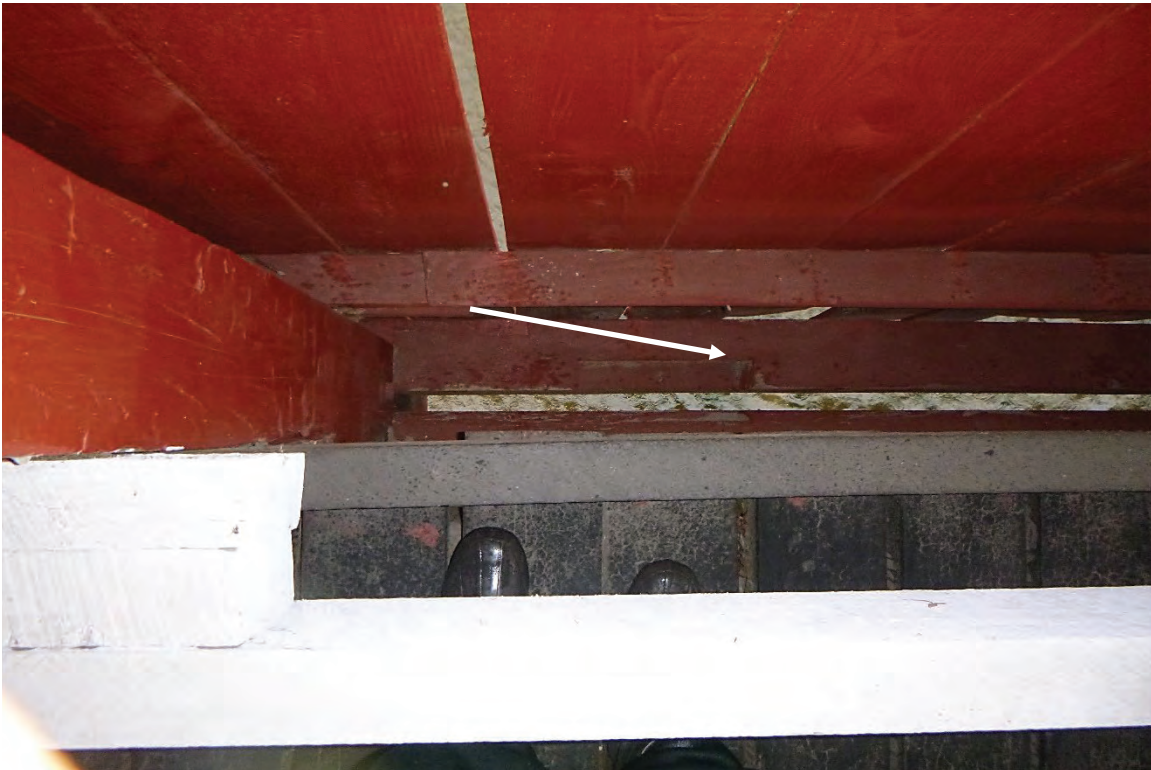
MISSING LOWER LONGITUDINAL KNEE BRACE AT L5 LEFT TRUSS

Note: No change.

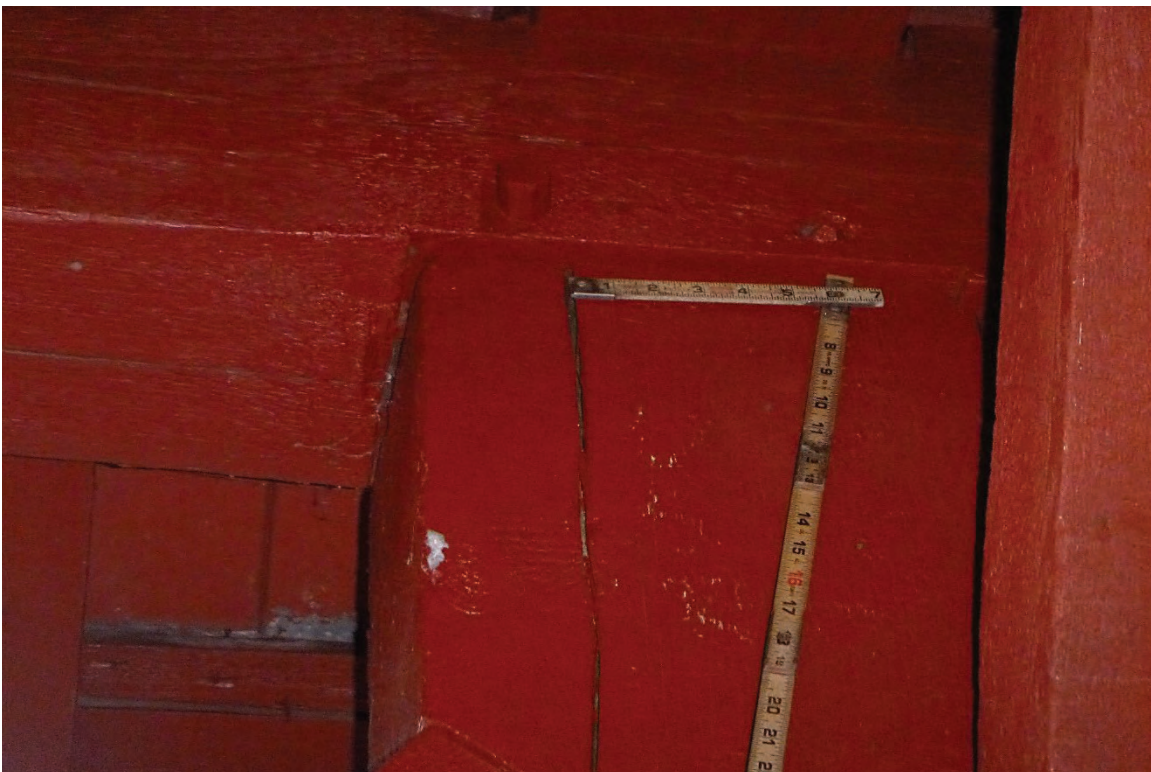
SPLIT IN VERTICAL U5L5 RIGHT ABOVE DIAGONAL NOTCH

Note: No change since the 2019 inspection.

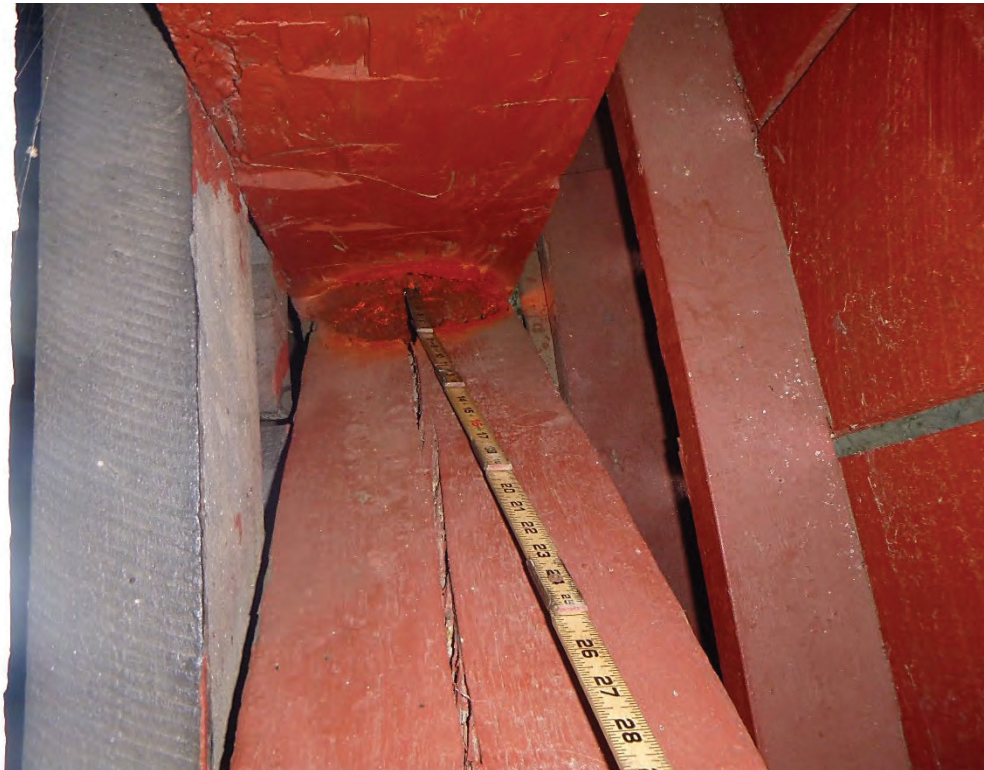
DECAYED VERTICAL AND DIAGONAL MEMBERS AT L6 RIGHT TRUSS

Note: Typical at L7 right truss. No change.

**Narrative:** Rating based on decay @ L6 and L7 connections on RT truss.

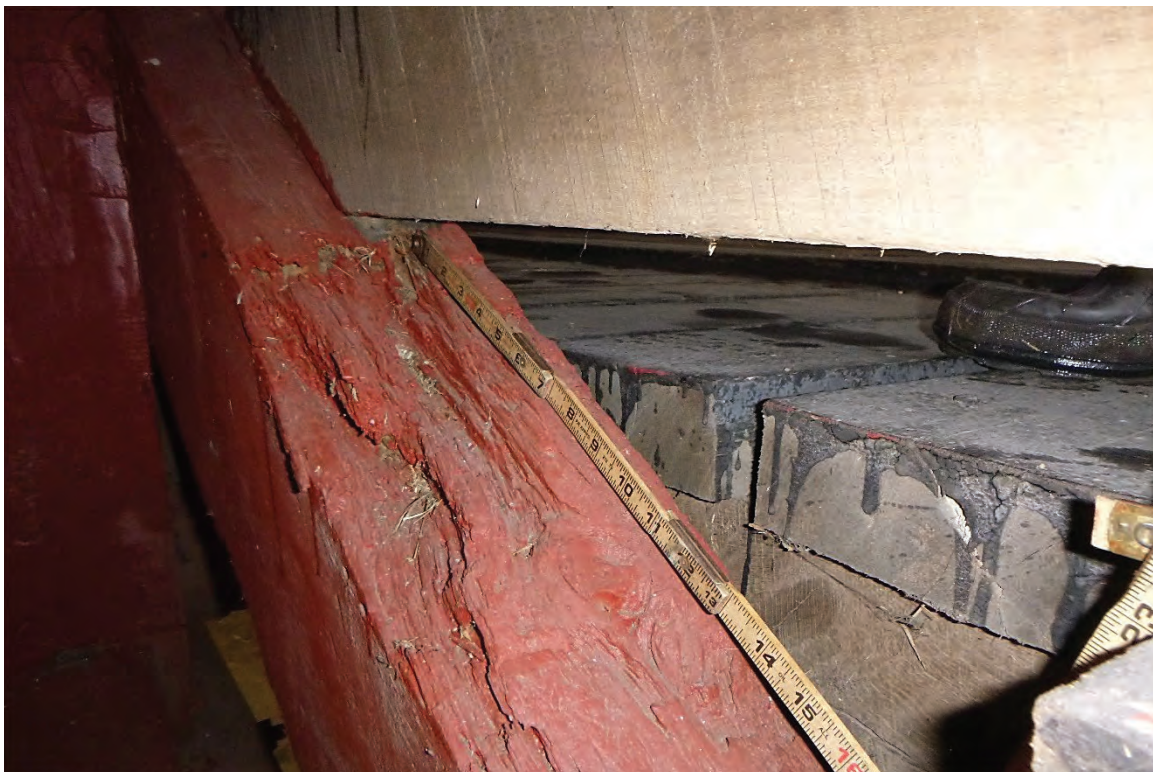
The original arch members exhibit minor checks, splits and isolated minor surface decay. The top of the interior arch at the far right has a decay behind the curb with no increase in decay since the 2016 inspection. The interior arches above the deck also have minor scrapes due to collisions. There are newer arch members spliced into the existing members. The splices are sound. The newer arch and low chord members are CCA treated.

DECAYED INTERIOR ARCH MEMBER AT FAR RIGHT

Note: No change in the decay.

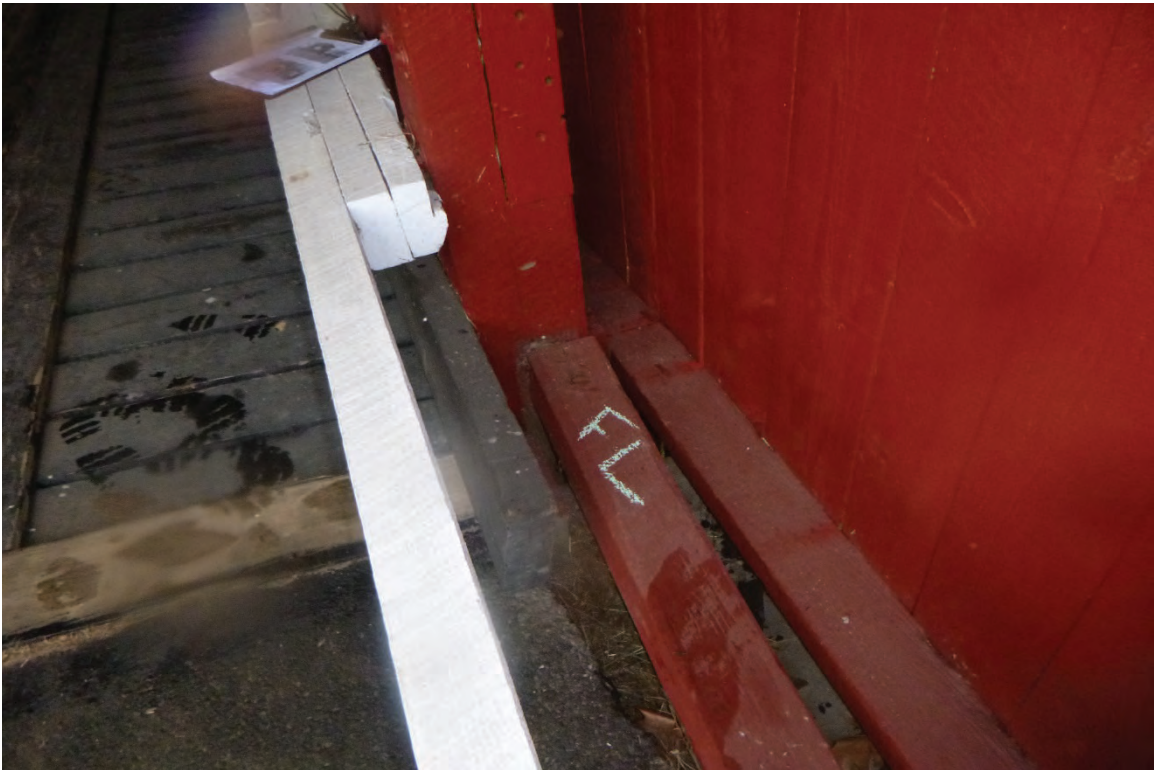
FAR LEFT PORTAL SILL

Note: Minor decay below the portal. Portal is not attached to the vertical member L8U8

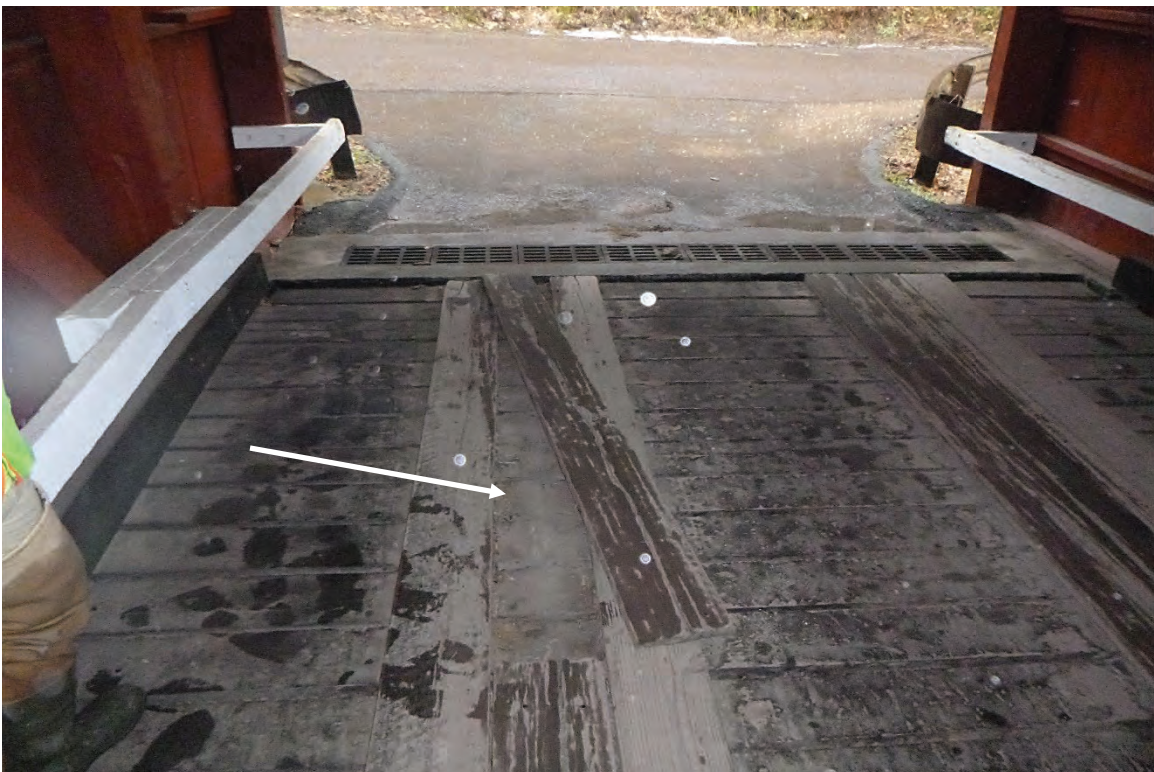
The center running board at the near end of the right wheel path is no longer attached to the deck but is confined by the adjacent boards. There was an increase in deterioration of the concrete encasement at the far abutment. Far left portal sill is loose and disconnected from the vertical L8U8. The far left portal sill also exhibits decay below the far left portal vertical.

LOOSE RUNNING BOARD IN THE NEAR RIGHT WHEEL PATH

Note: New in 2021.

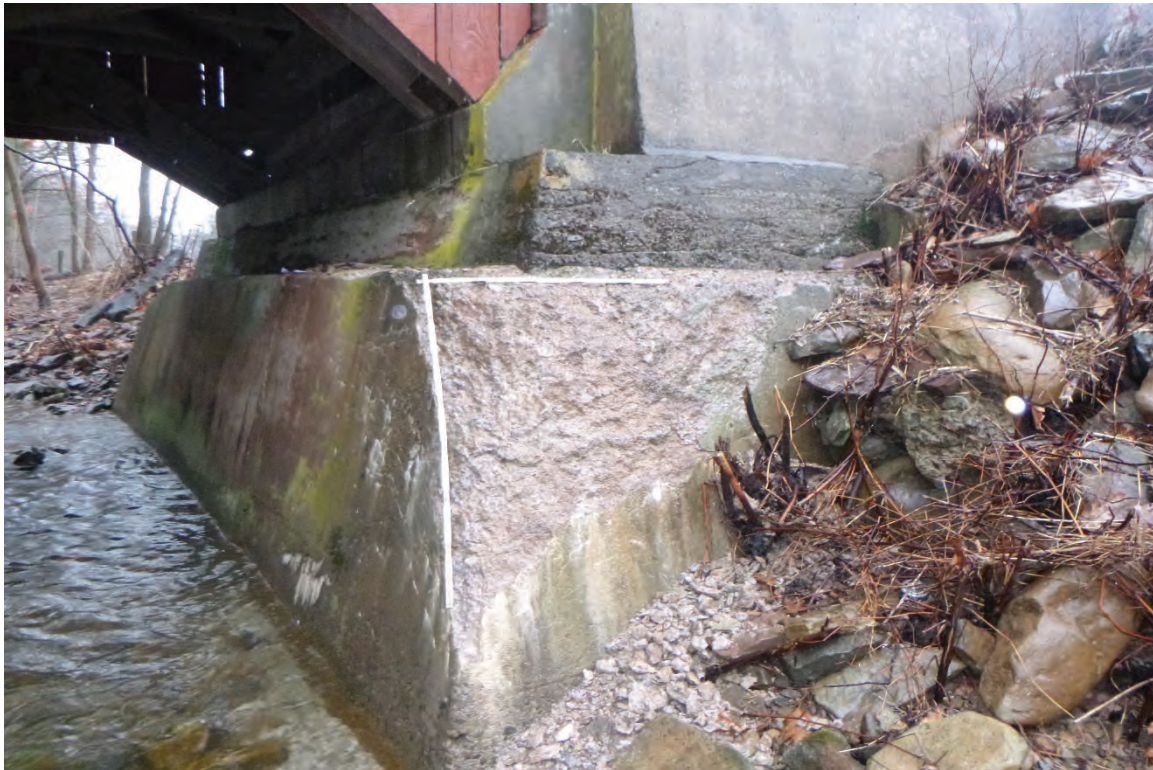
The top tier of the concrete encasement on the far abutment exhibits moderate scaling in the older portions with light scaling at the waterline, areas of unsound concrete, and a full height vertical crack at the left end with edge spalling. The bottom tier exhibits moderate deterioration, areas of unsound concrete, and horizontal and vertical hairline cracks with moderate efflorescence. There is concrete deterioration at both corners that has increased slightly since the 2017 inspection. The deterioration at the left corner is active with adjacent unsound concrete. There is a full height hairline vertical crack adjacent to the right bottom chord and below Stringer 2.

FAR RIGHT ABUTMENT CORNER

Note: Deteriorated and unsound concrete; typical at far left. Slight increase since 2019.
