2021 ROUTINE BRIDGE SAFETY INSPECTION REPORT

Cleveland Township, Columbia County
T-373 (Esther Furnace Road) over Roaring Creek
County Bridge No. 11
BMS No. 19-7205-0373-0011
BRKEY: 12786

March 24, 2021
C1
12 Months
Dale J. Sitler, P.E., C.B.S.I.
and
Andrew J. Susen, C.B.S.I.

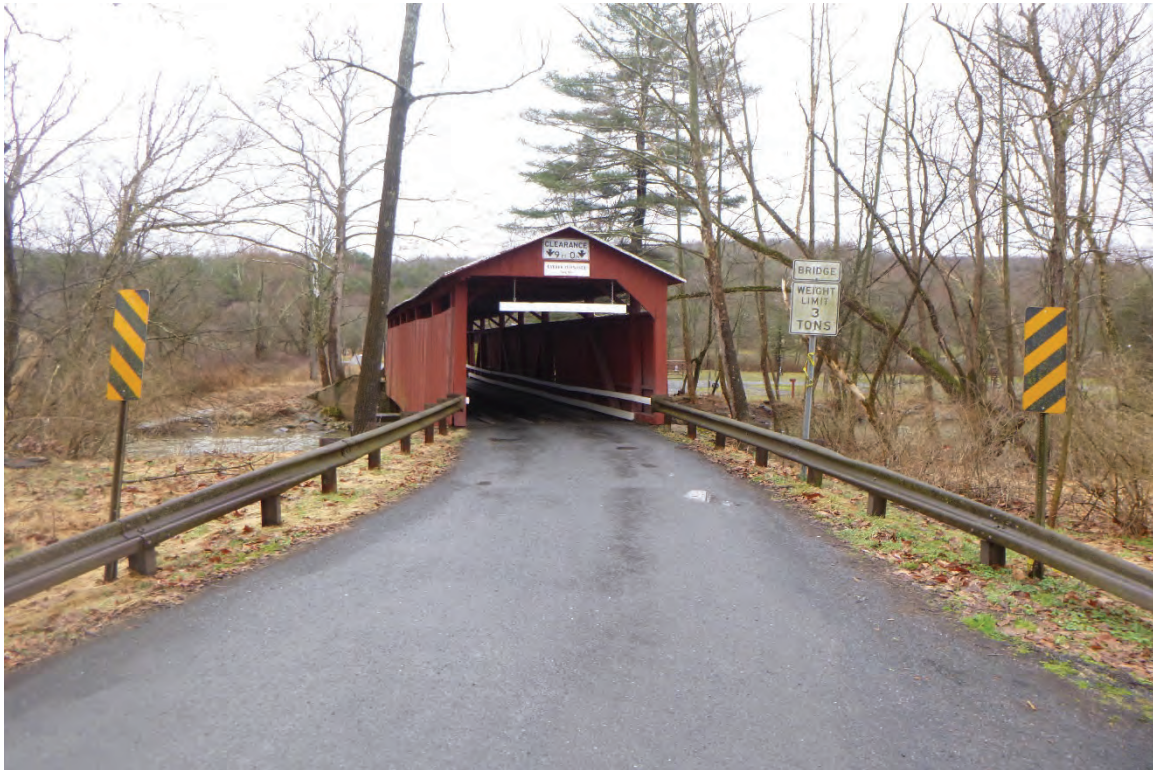
NEAR APPROACH

Note: Near Bridge Load Posting is covered with dirt. Remains legible.

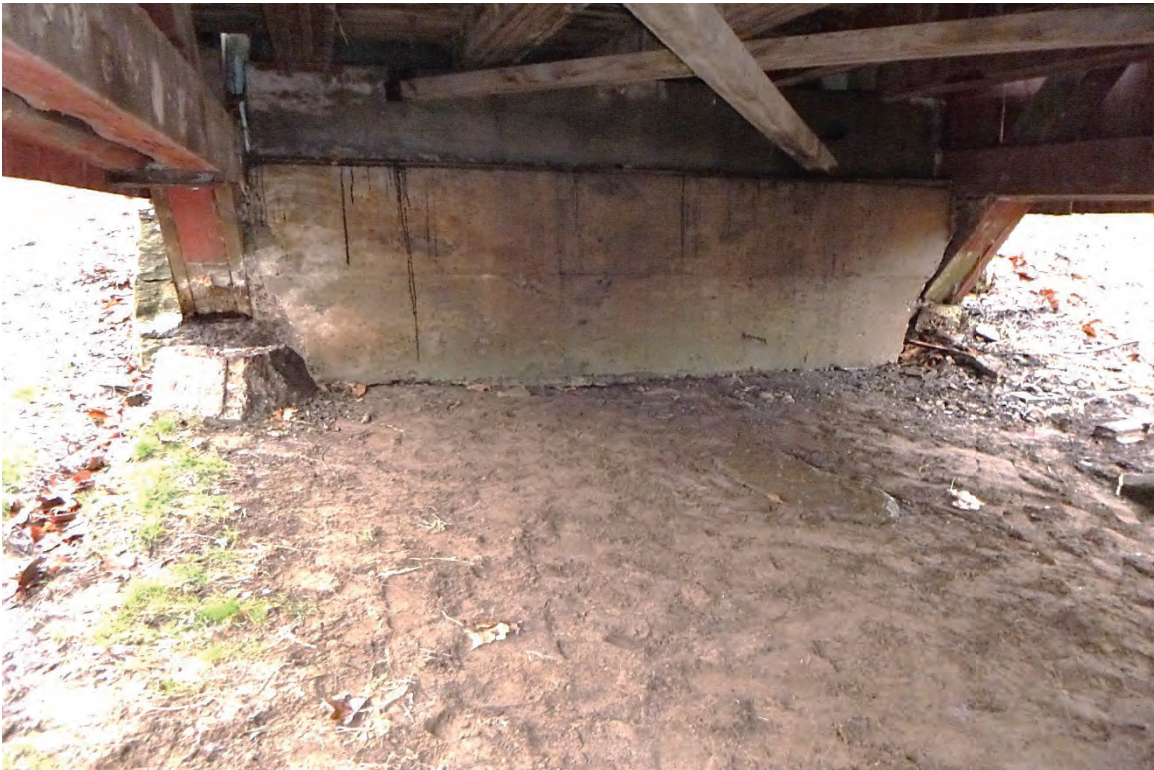
NEAR ABUTMENT

The near concrete encased stone masonry abutment stem consists of two tiers. The upper tier exhibits a hairline vertical crack. The lower tier concrete encasement exhibits broken concrete at the left and the

right end of the abutment, exposing the original stone masonry abutment stem. The concrete encasement does not provide any bearing and the rest of the concrete encasement is secure. The portion of the encasement missing at the right end of the abutment is new in 2021. The stone masonry stem exhibits mortar cracking. Water leakage is visible from the roadway between S1 and S4.

Note: The encasement below the right end post has fractured. New since 2020.

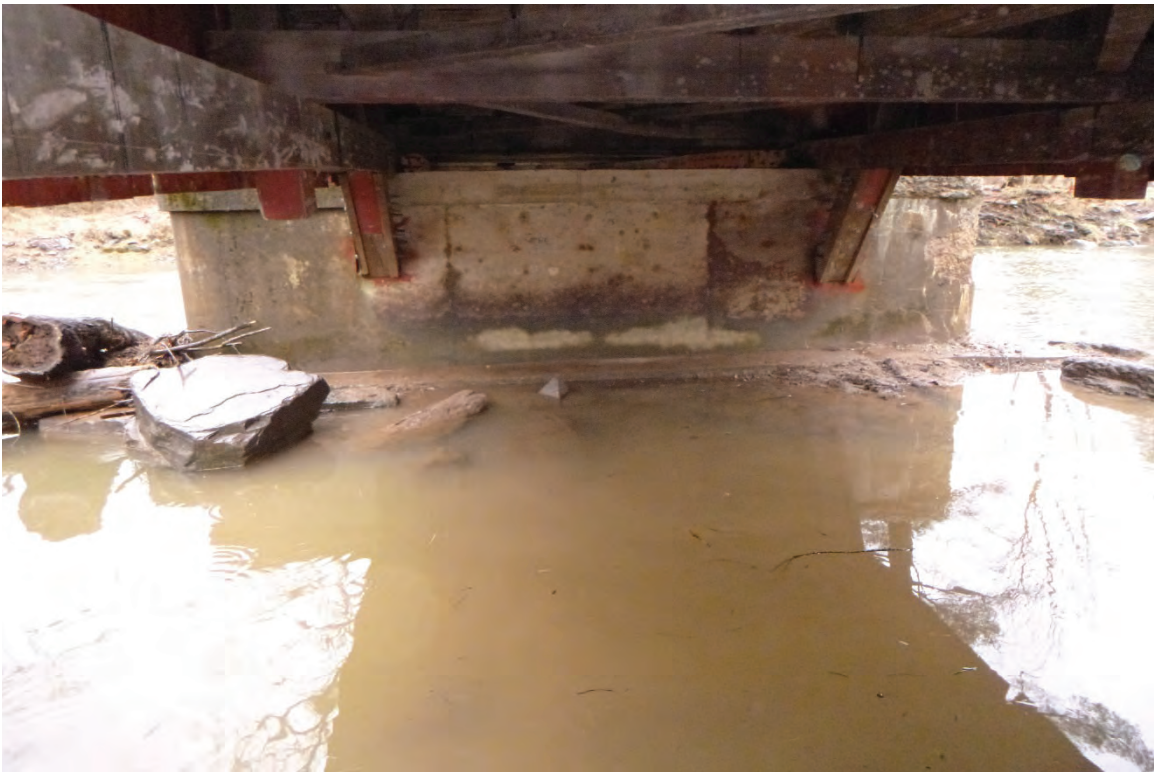
TYPICAL VIEW OF PIER

Note: Far side shown.

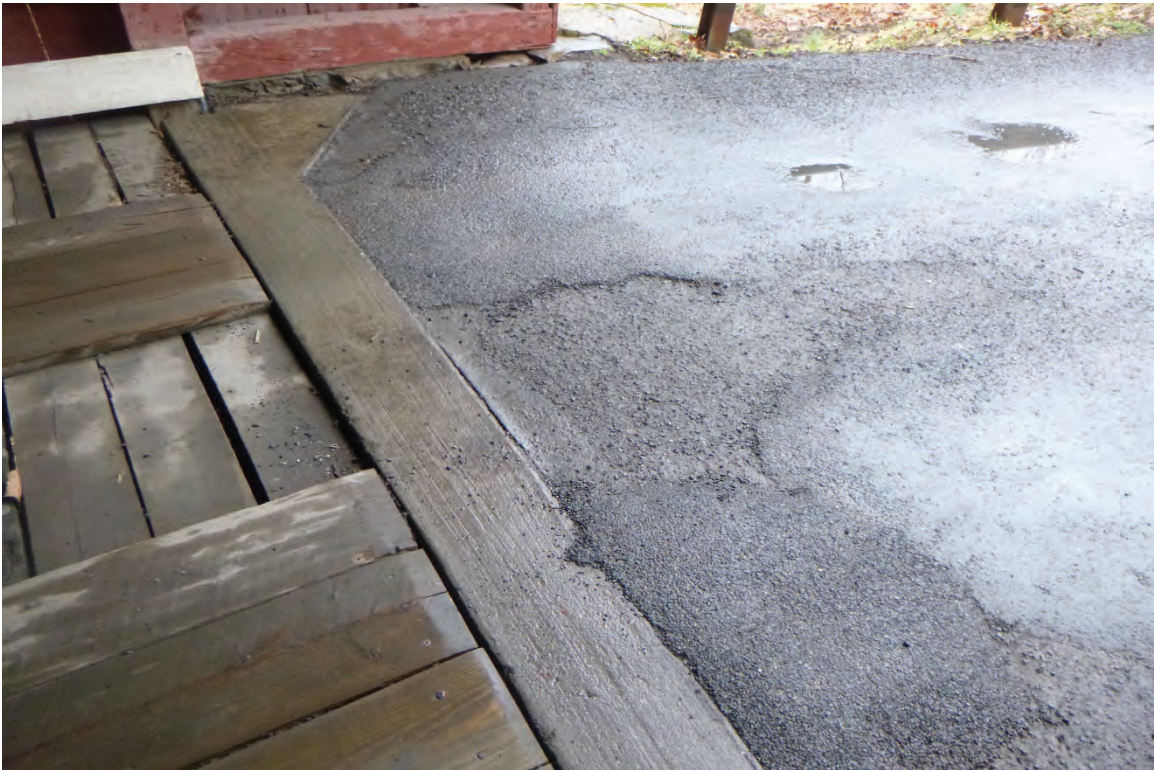
DETERIORATION IN NEAR APPROACH ROADWAY

The near bituminous approach roadway pavement exhibits minor wear and rutting. There are new patches in the near left and right wheel paths since the 2020 inspection. There is a cracked and depressed area in the near right wheel path up to 2" deep. The far approach roadway has a newer patch for 10' with depressions and cracks in the wheel paths. There are newer bituminous patches in the wheel paths at the back of the backwall that are settled up to 1".

Note: New bituminous patches in the roadway since 2020.

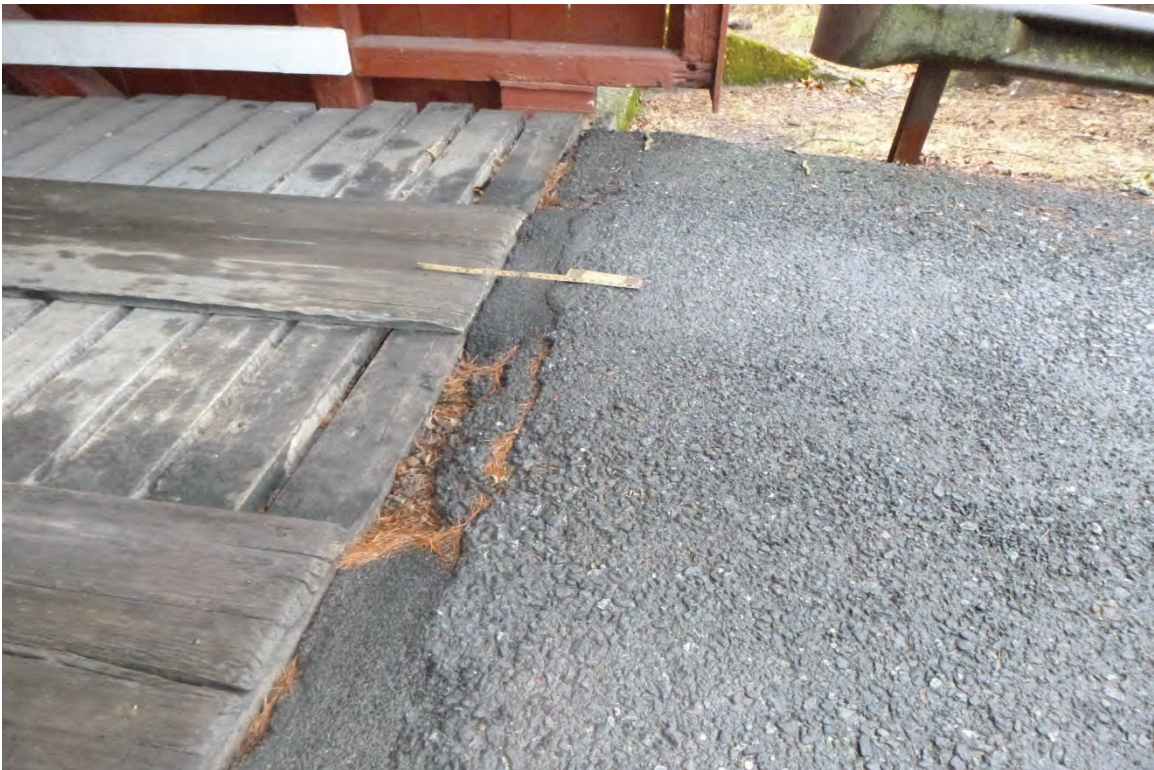
PATCHES IN THE FAR APPROACH ROADWAY

Note: The patches are new since the 2020 inspection. Settlement of the patches.

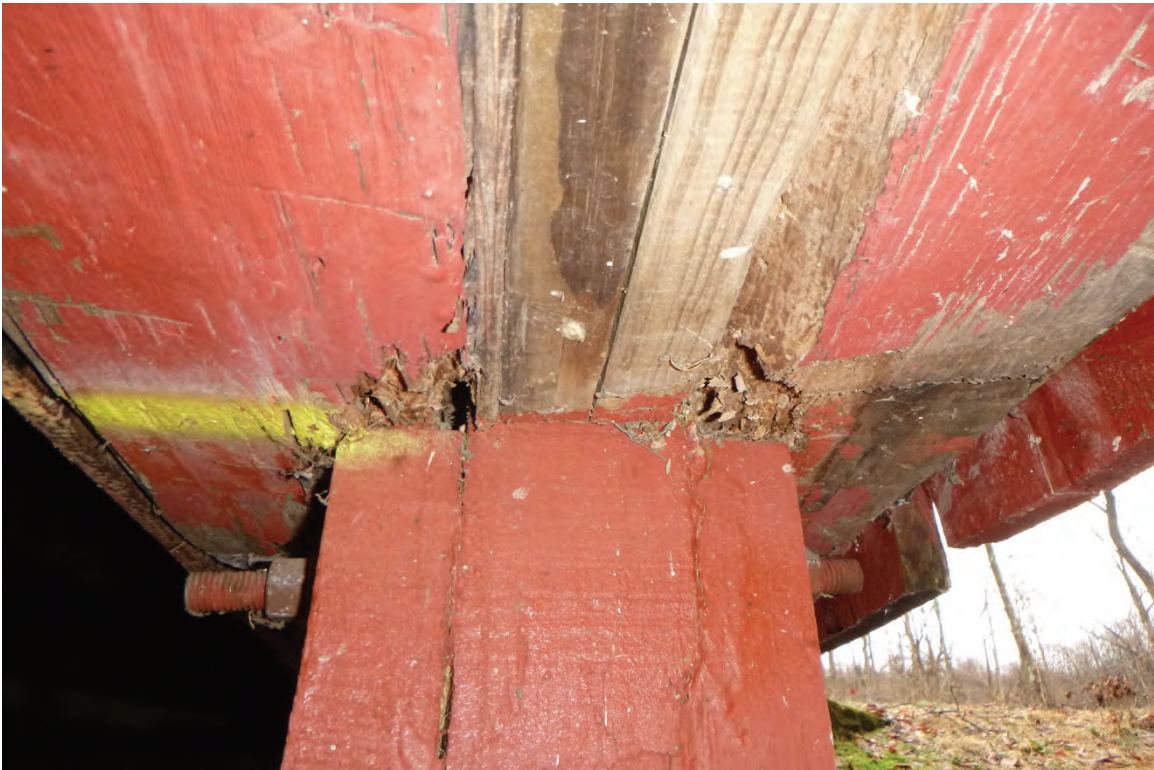
DECAY IN THE EXTERIOR LOW CHORD AT FAR SIDE OF U1L1 Left

Note: No increase in decay.

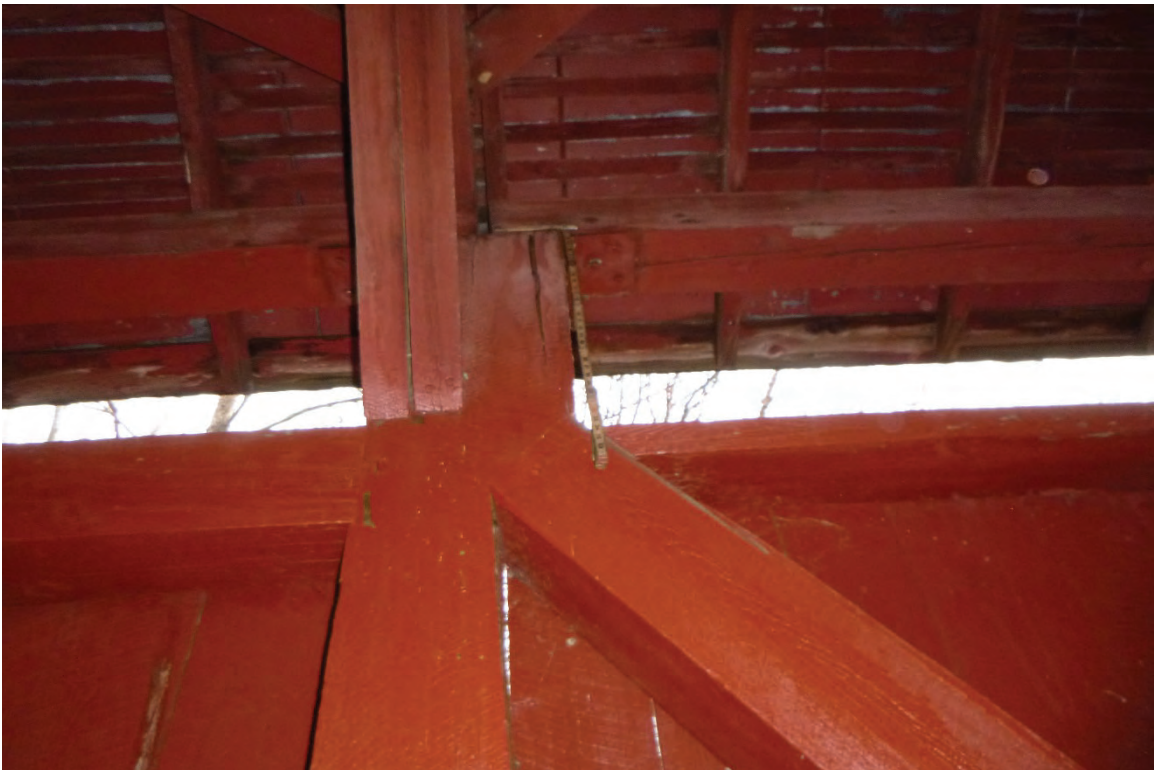
SPLIT AT THE TOP OF U2L2 RIGHT

3. Repair or replace member U2L2 at the left truss, U3L3 at the left and right truss due to the large splits at top above the notch for the diagonal member (\$15,000). **

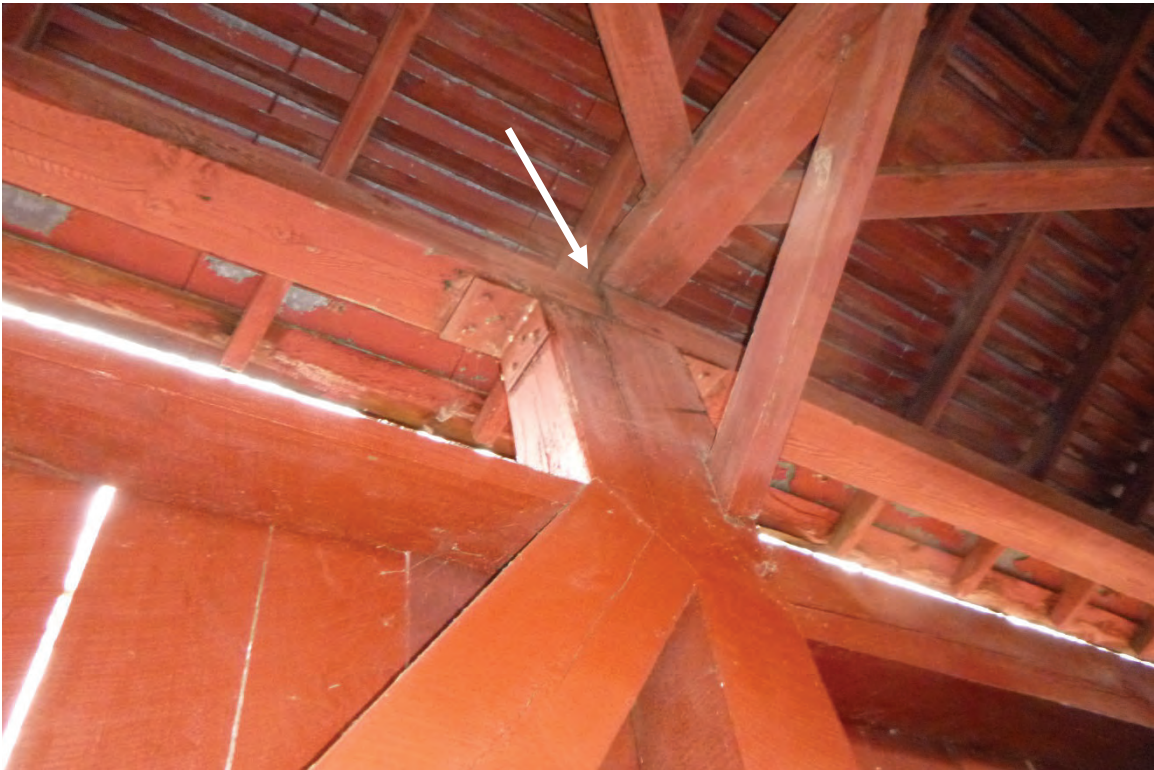
DISPLACEMENT OF THE LAP SPLICE CONNECTION AT U3 LEFT TRUSS

Note: No change in displacement.

1. Repair the loose knee brace connection at U5 on the right truss (\$5,000). **
2. Repair the displaced lap splice connection at U3 on the left truss (\$5,000). **

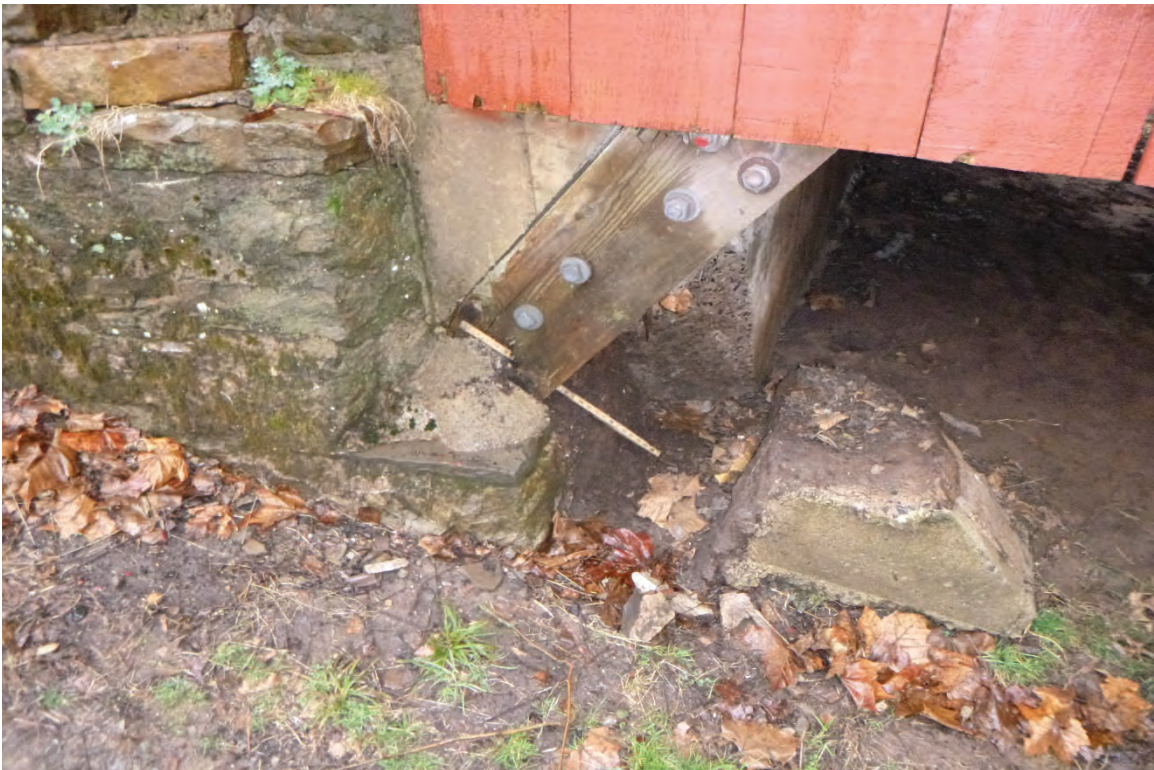
NEAR RIGHT TRUSS END POST

Note: Decay at the base of the member. No increase since the 2020 inspection.

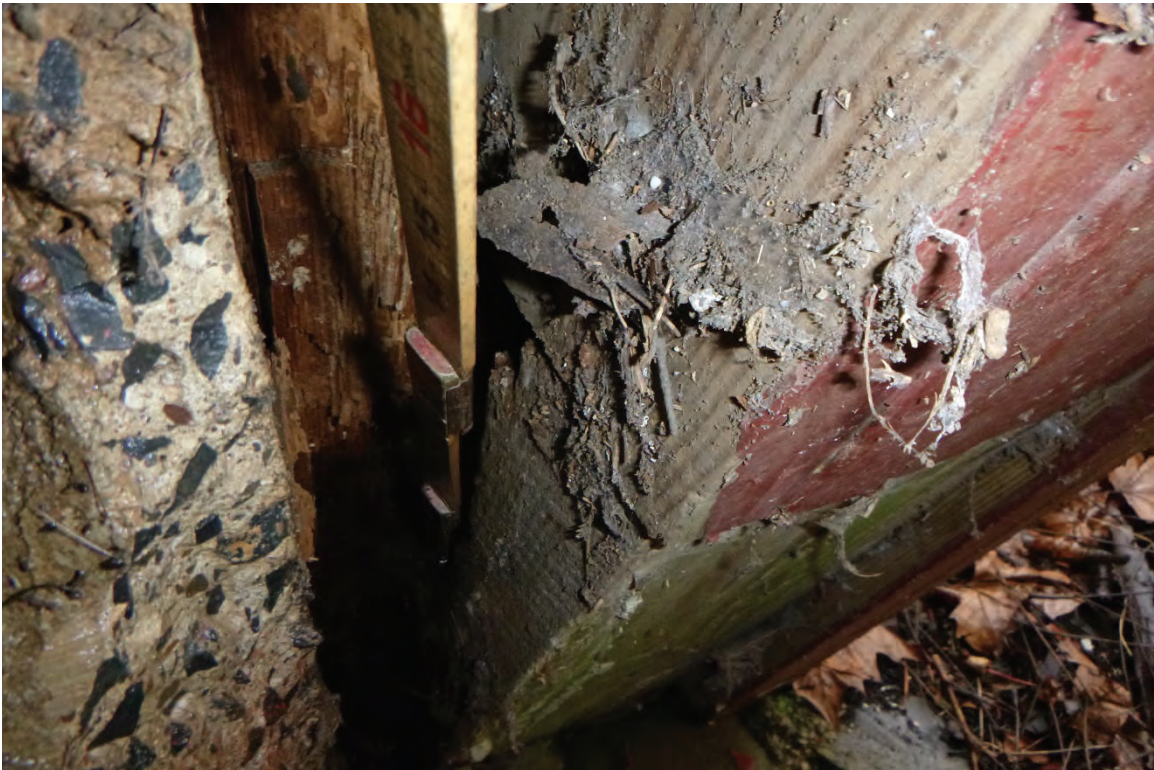
NEAR LEFT TRUSS END POST

The upper chord of the left in Span 1 is significantly bowed inward with heavy checking on underside and interior side. The truss end post at the near left was previously encased in concrete; the concrete has broken off and exposes entire end of end post which exhibits moderate decay. Interior laminated piece is missing approximately 50% of area due to decay with 3.5" high by 3" deep area of decay on the interior face of the middle end block. The concrete encasement at the near right end post has broken off in 2020. There was an increase in decay at the near right end post since the 2020 inspection. The end post at near right bearing exhibits heavy decay in the exterior lamination and minor decay to the middle block. There is heavy decay with minor crushing of the timber at the right end post bearing at the far side of the pier. There is decay of the middle block and the right laminated block. The decay results in approximately 50% loss of the total area of the section. The decay is not considered a critical situation due to the short distance between the end post connection to the low chord and the low chord bearing. No movement under live load is observed. There was an increase in the decayed area since the 2019 inspection. There is moderate decay at the far left and right end post section bearing at the far abutment.

Note: Increase in decay to the interior laminated member since 2020.

1. Install current standard transition guide rail at all four corners (\$4,000). **
2. Replace Floorbeam 2 due to the severe check at mid-span (\$5,000). **
3. Repair the separated header beam connections at U4 left and right truss (\$10,000). **
4. Repair the decayed end post bearing at the right truss on the far side of the pier (\$5,000).
5. Repair the decayed exterior low chord member in Span 1 left truss adjacent to member U1L1 (\$5,000). **
6. Repair or replace the decayed near left end post at the near abutment (\$5,000). **

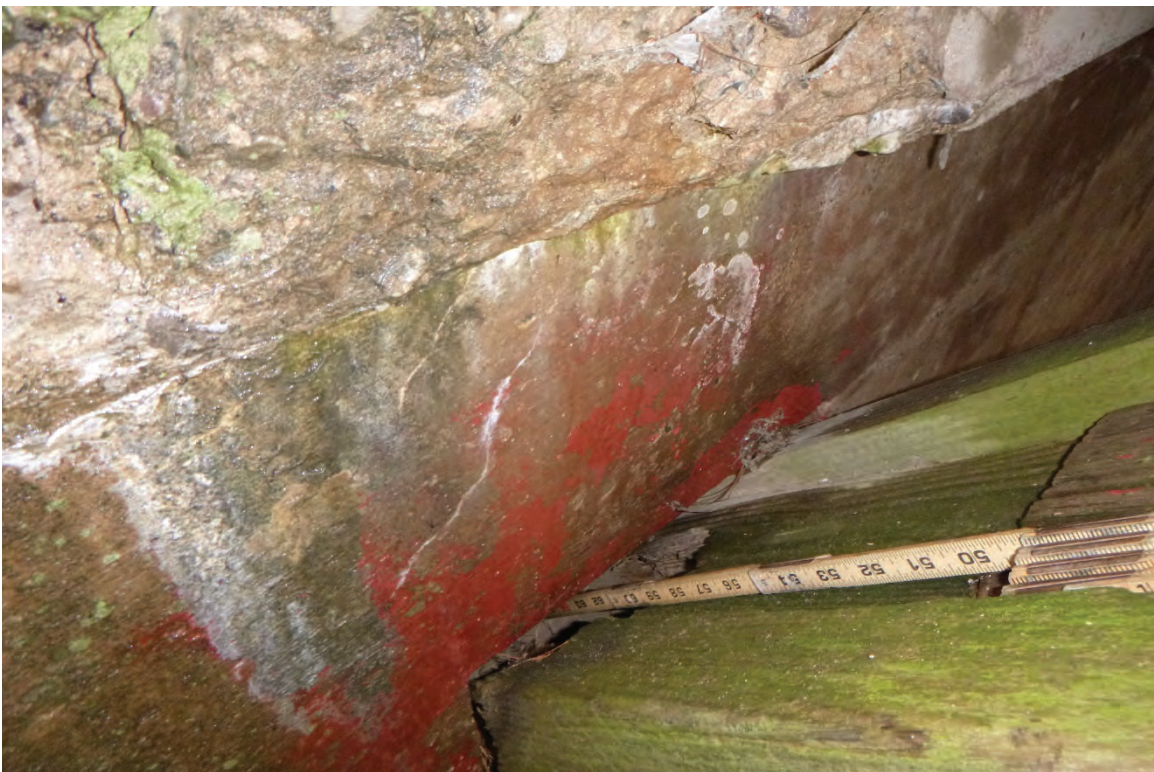
There was an increase in the decay at the near right end post, in Span 2, at the far side of the pier over the last several inspections. This results in a large area of the bearing end of the end post being decayed; however, the decay is not critical at this time due to the short distance between the end post connection to the low chord and the bearing for the low chord. We recommend the end post be repaired or replaced in the near future. Increased decay may result in High Priority Deficiencies, Critical Deficiencies, or closure of the structure.

DECAYED RIGHT END POST AT THE FAR SIDE OF PIER

Note: Increase in decay since the 2018 inspection.

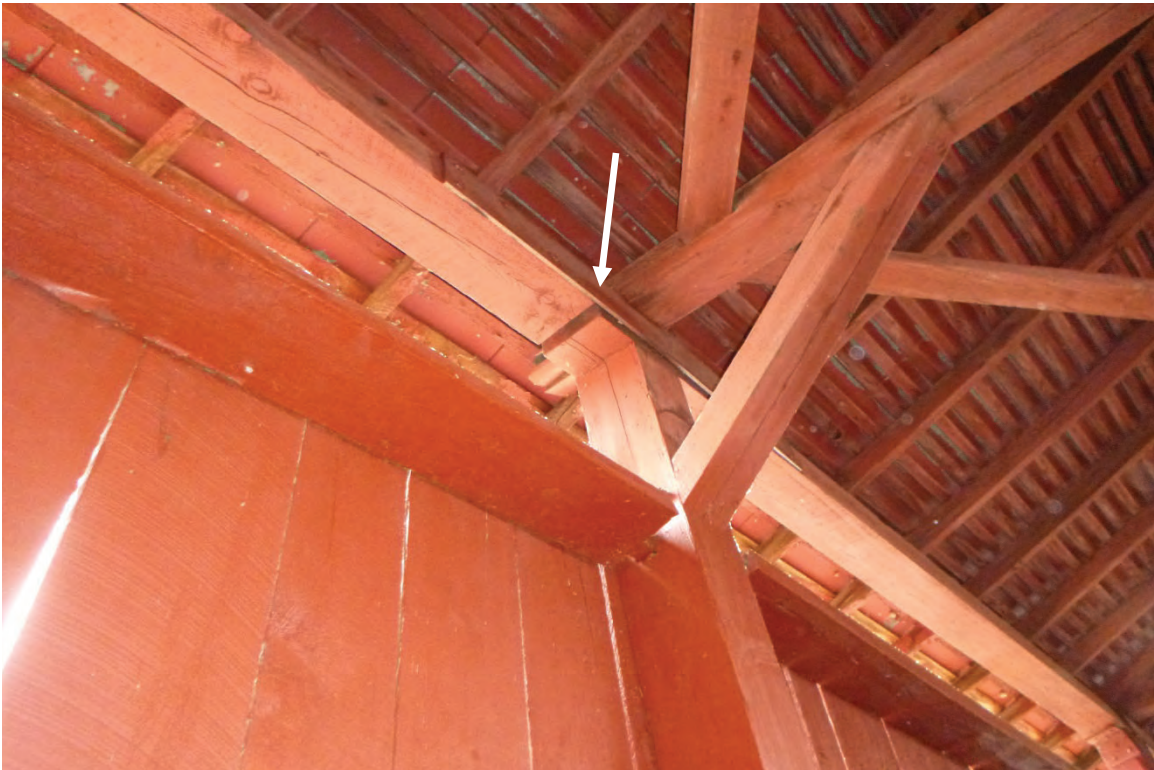
The solid sawn timber Queen Post Truss exhibits minor to moderate checks and splits throughout and a few areas of insect damage. There is a hole above the L1U1 knee brace connection to the right truss due to insect damage. The header beam connections are pulling apart at U4 left and right trusses, and at the left and right ends of the far portal header. There is a 1" gap at the vertical connection at U0 right truss. There are heavy full height checks in truss members L1U1 right truss, L5U5 right truss, and L2U2 left and right trusses. The diagonals exhibit checking up to 1/8" wide with up to 1.25" deep awl penetration. All of the steel plate repairs, nail laminated repairs, and splices appear to be stable except the longitudinal roof support beam above U3 left. The roof support beam on the left side between U2 and U3 is laterally displaced inward with two of the four lag bolts on the far end steel plate splice pulling out slightly with apparent movement toward the near end. There are no steel connection angles between the upper chord and the vertical at this location. There has been no increase in the displacement since the 2016 inspection. There is a 1/2" wide split on the far side of vertical U3 and 1/8" wide at the near side on the left truss between the siding nailer board and the roof support. There has been no change since the 2017 inspection. The top of the vertical at U3 on the right truss is splintered at the roof support connection parallel to the knee brace. There is a 5/8" wide split above the end post connection notch at U2 in the left and right trusses with heavy splits on the near side of the right and far side of the left verticals. The roof support beam is twisted at U4 on the left truss. The splits and displacement were caused by the floorbeam failure in 2006 and have not changed significantly since the failure.

MISALIGNED HEADER BOARD AT U4 LEFT

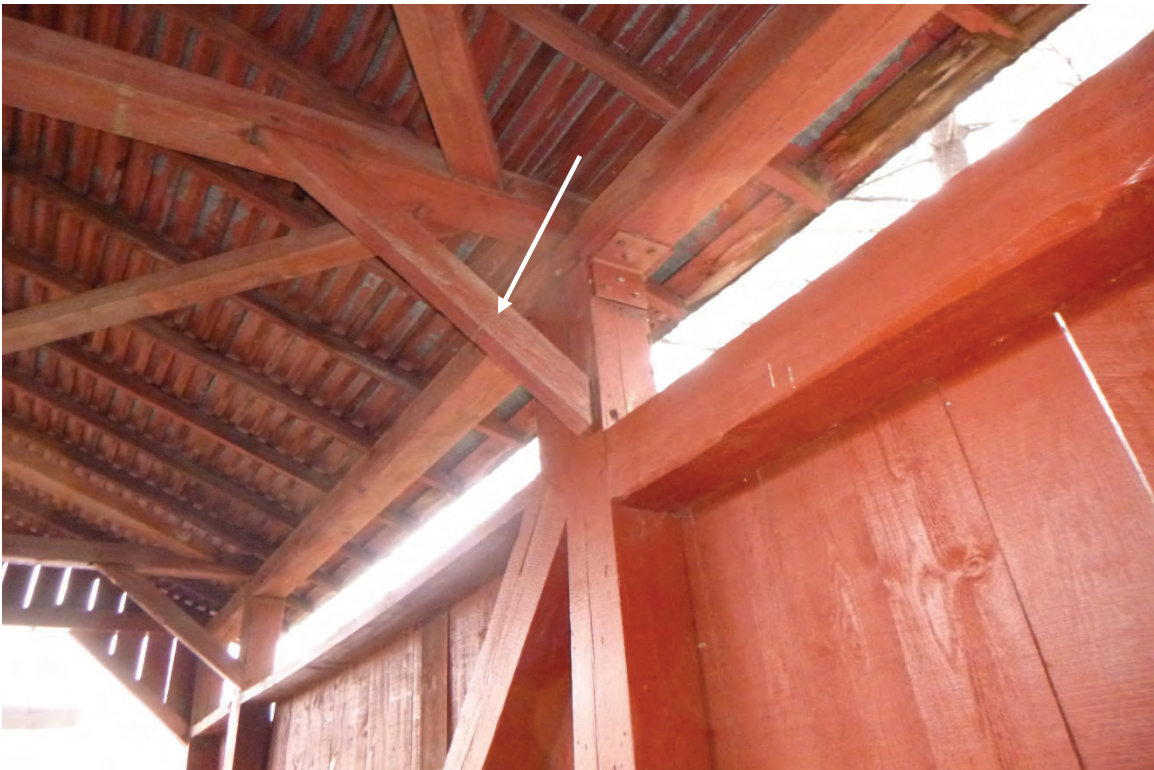
LOOSE KNEE BRACE AT U5 RIGHT

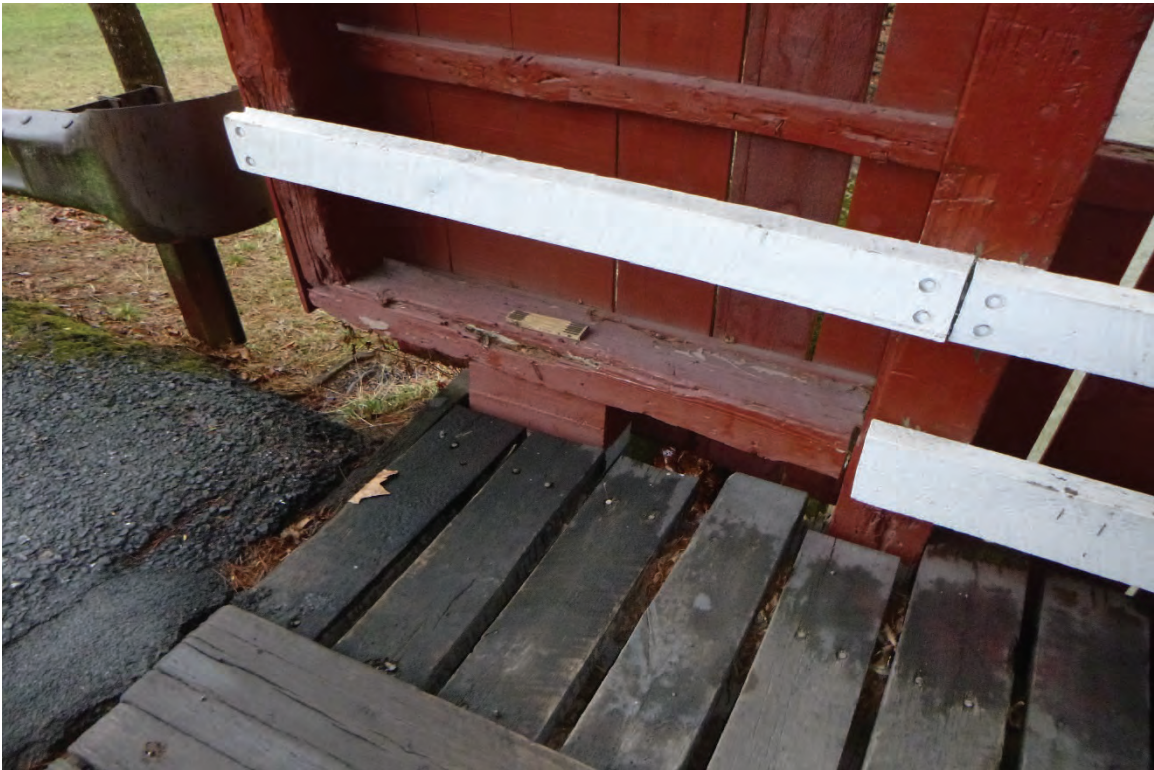
The portals exhibit moderate to heavy checks and splits. The portals exhibit moderate to severe decay and insect damage at the bottom of the verticals and the sills. There is a nail laminated repair at the near left sill. The near left portal vertical and L0U0 have a very minor scrape from a vehicle impact. The top of the far portal siding was been knocked off the bridge due to the 2016 vehicle impact. The lower lateral brace from L2 left to L3 right has been repaired with a steel plate, and the lower lateral cross brace from L3 right to L4 left has been replaced. The lower lateral brace from L0 Left L1 Right exhibits heavy decay at L0 and is detached from the near abutment connection. The detachment is new in 2021. The knee brace at U5 on the right truss is loose due to a missing dowel at the U5 connection.

DECAY IN SILL PLATE AT FAR RIGHT PORTAL

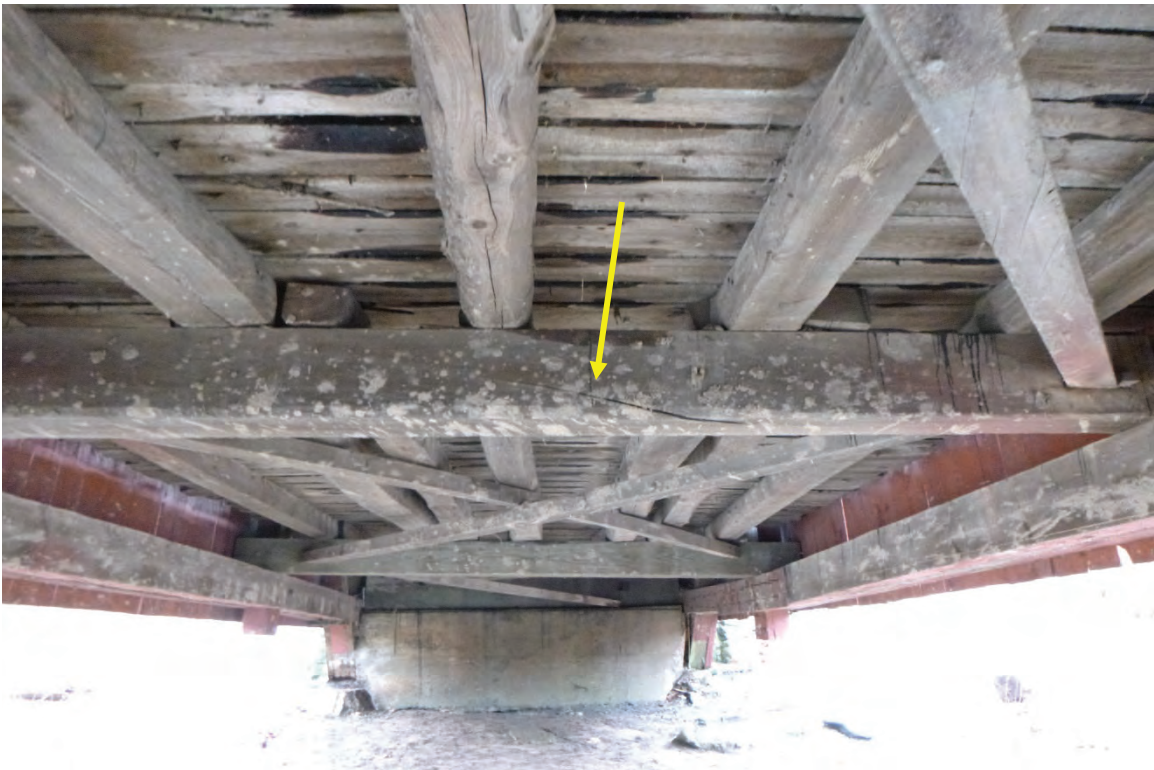
The solid sawn timber floorbeams and stringers exhibit minor to moderate checks and splits throughout. Floorbeam 1 was replaced in 2006. There is a severe, half-height diagonal check in Floorbeam 2 that has not increased since it was initially noted in 2004.

HEAVY CHECK ON FAR SIDE OF FLOORBEAM 2

Note: No change in the size of the check for several inspections.

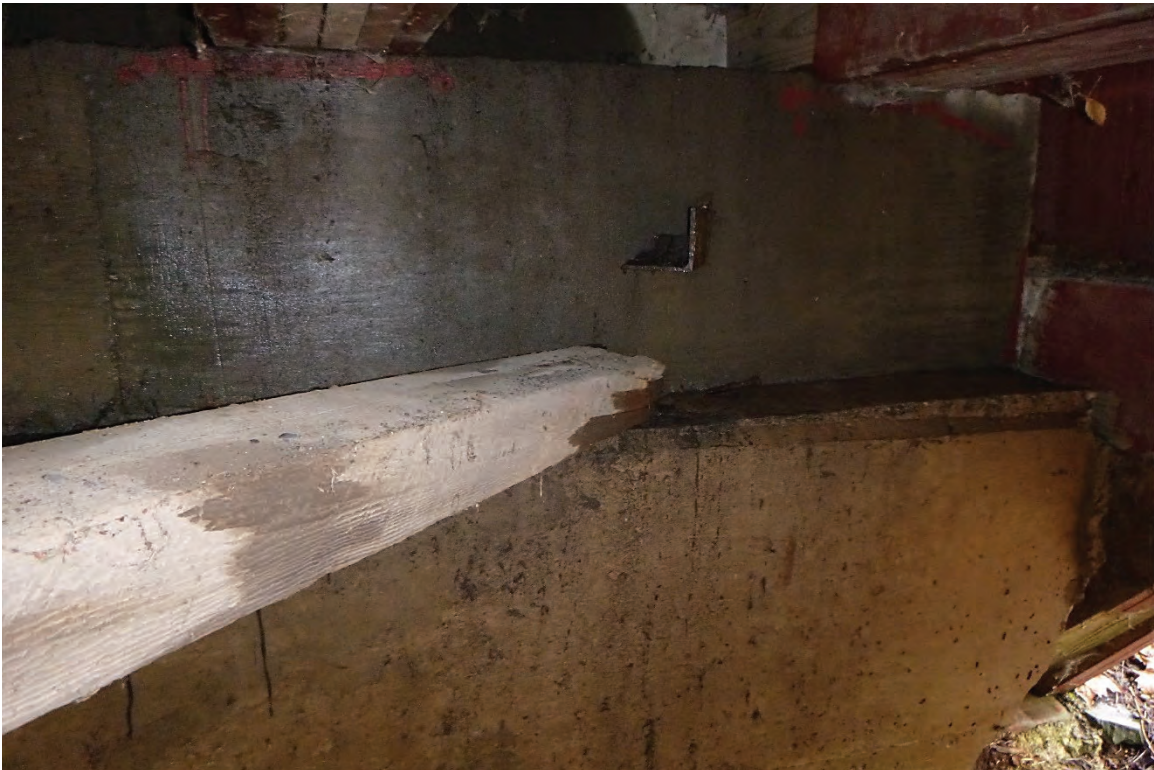
LOWER LATERAL BRACING L0 LEFT L1 RIGHT

Note: Timber is disconnected from the abutment.

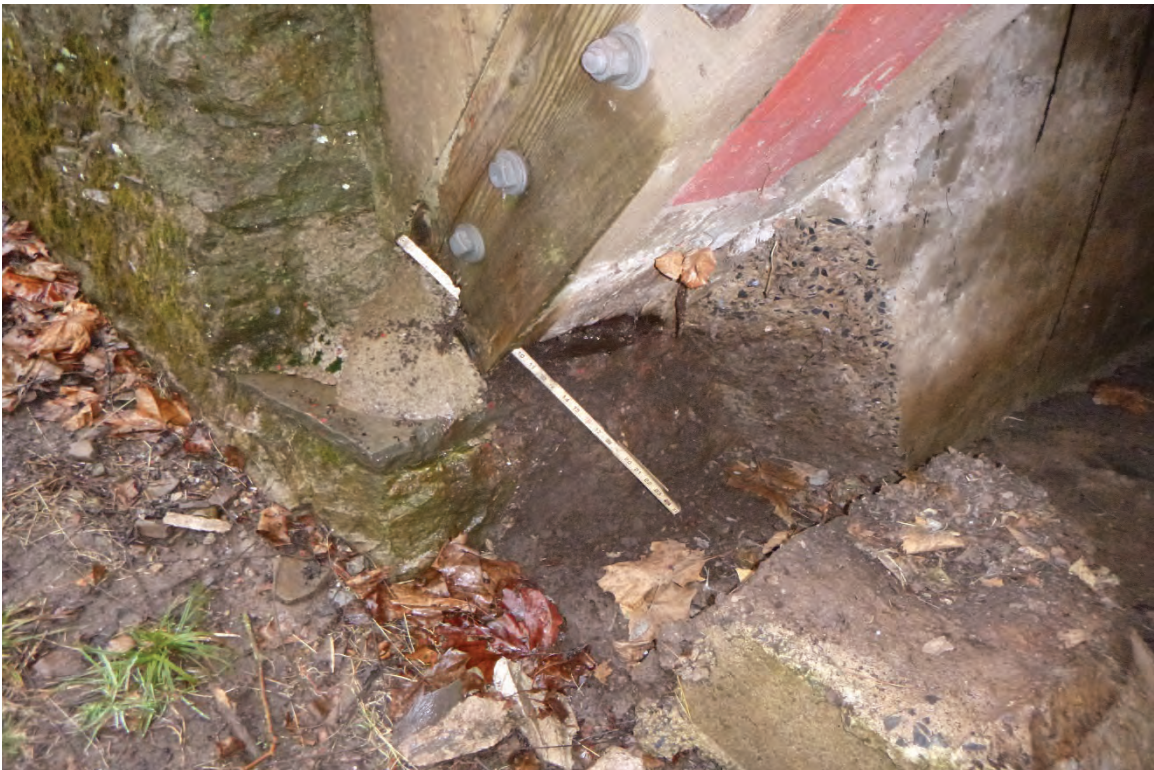
CONCRETE ENCASEMENT AT NEAR RIGHT TRUSS BEARING

Note: Encasement is fractured since 2020; stone masonry is stable. The left end post bearing is typical.

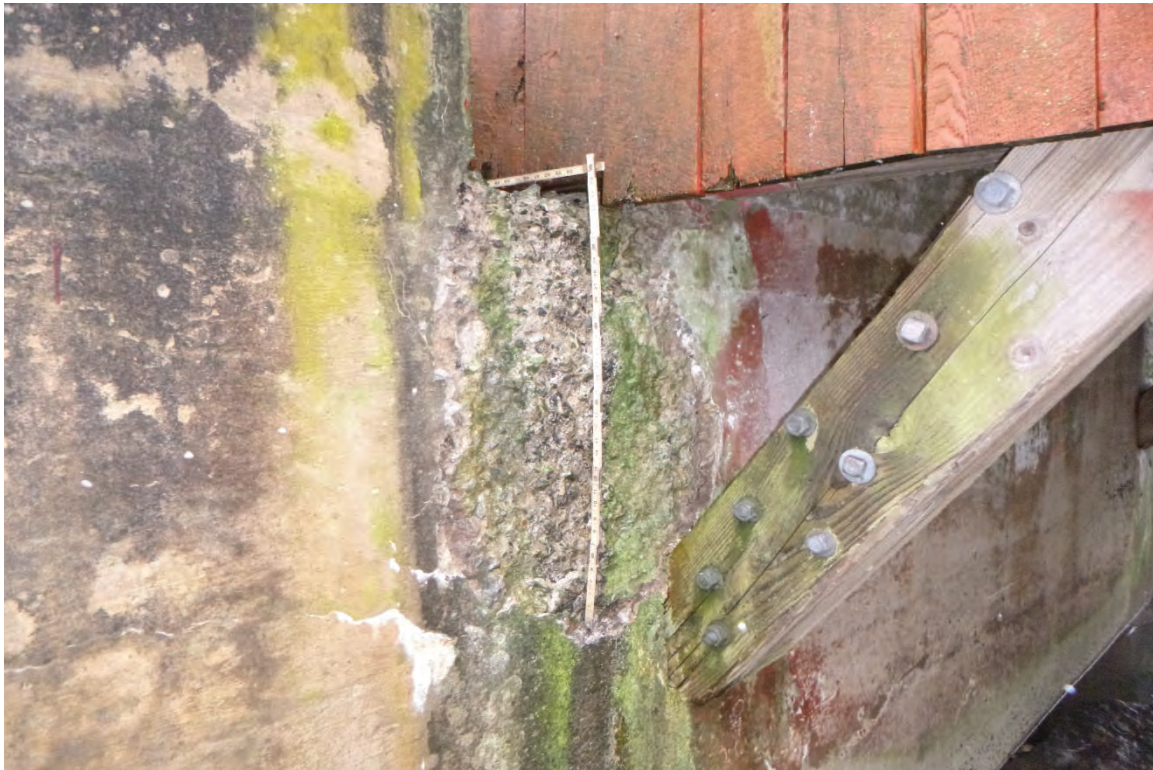
The low chord and truss bearing seats at the far abutment are concrete and exhibit cracks, unsound concrete, and efflorescence at the connections. The stringers at the far abutment bear on timber with a concrete lower portion. The timber exhibits minor checks and splits. The concrete exhibits moderate honeycombing and three large construction defects at the areas of the large encased rock and unsound concrete.

The far concrete abutment stem exhibits light to moderate scaling along the bottom. A full height, 3/8" maximum width crack with 1/8" displacement extends from the left low chord seat through the truss seat to the ground, there was no change since the 2007 inspection. There are areas of unsound concrete and efflorescence adjacent to the crack and at the seats. There are also areas of delamination and efflorescence at the right lower chord and truss seats with areas of deterioration. There is hairline map cracking with minor efflorescence at the left end.

CONCRETE DETERIORATION AT THE FAR ABUTMENT

6. Repair the deteriorated concrete at the far abutment (\$1,200). **
7. Repair the deteriorated concrete on the pier at the downstream end (\$1,200). **

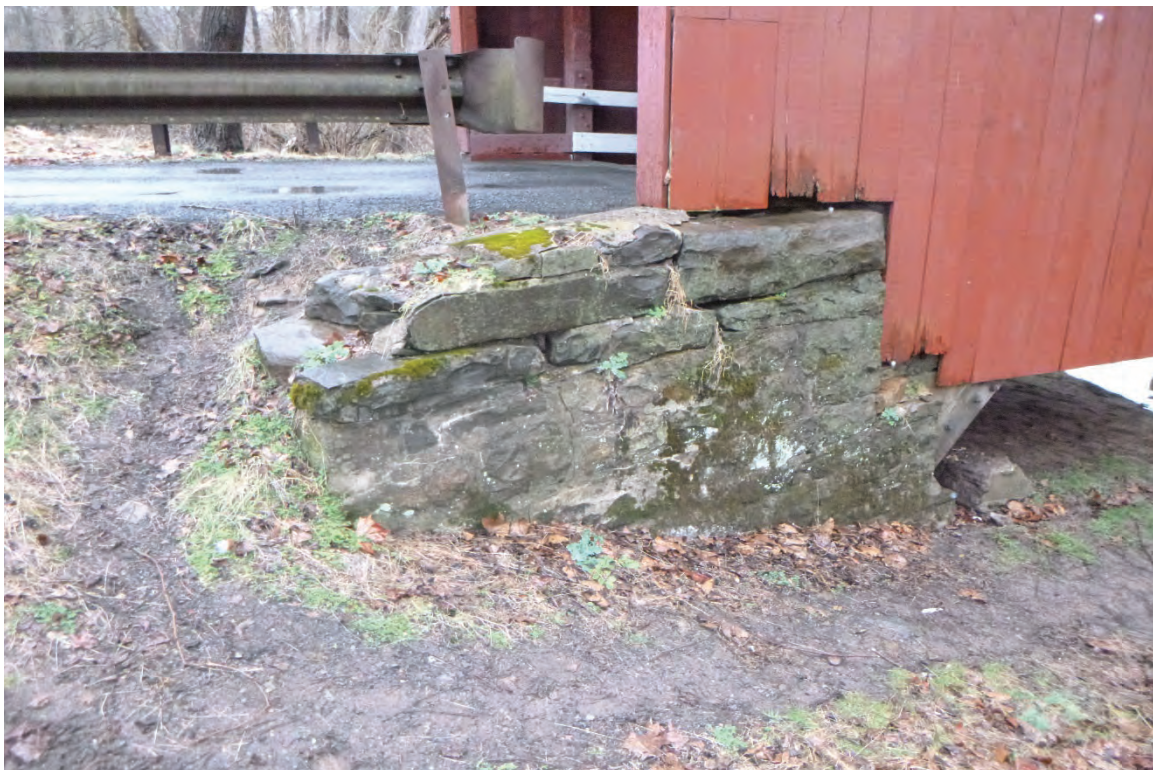
NEAR RIGHT WINGWALL

The near wingwalls are stone masonry with minor mortar cracking and areas of missing mortar. The near right wing exhibits mortar loss on the top third of the wing and has several cracked stones. At the near right free end, there are missing cap stones and three courses of stone are loose. The far integral concrete wingwalls exhibit minor honeycombing, isolated areas of hairline cracking with minor efflorescence, and deterioration on top at the free ends. There are areas of unsound concrete throughout the far left wing and isolated areas of unsound concrete in the far right wing. The far left wing exhibits a full length hairline horizontal crack 4' from the top of the fixed end.

Note: Deteriorated and missing mortar; typical at near left.

4. Repair the deteriorated concrete at the far wingwalls (\$1,200). **
5. Re-point the deteriorated portions of the stone masonry in the near wingwalls (\$200). **

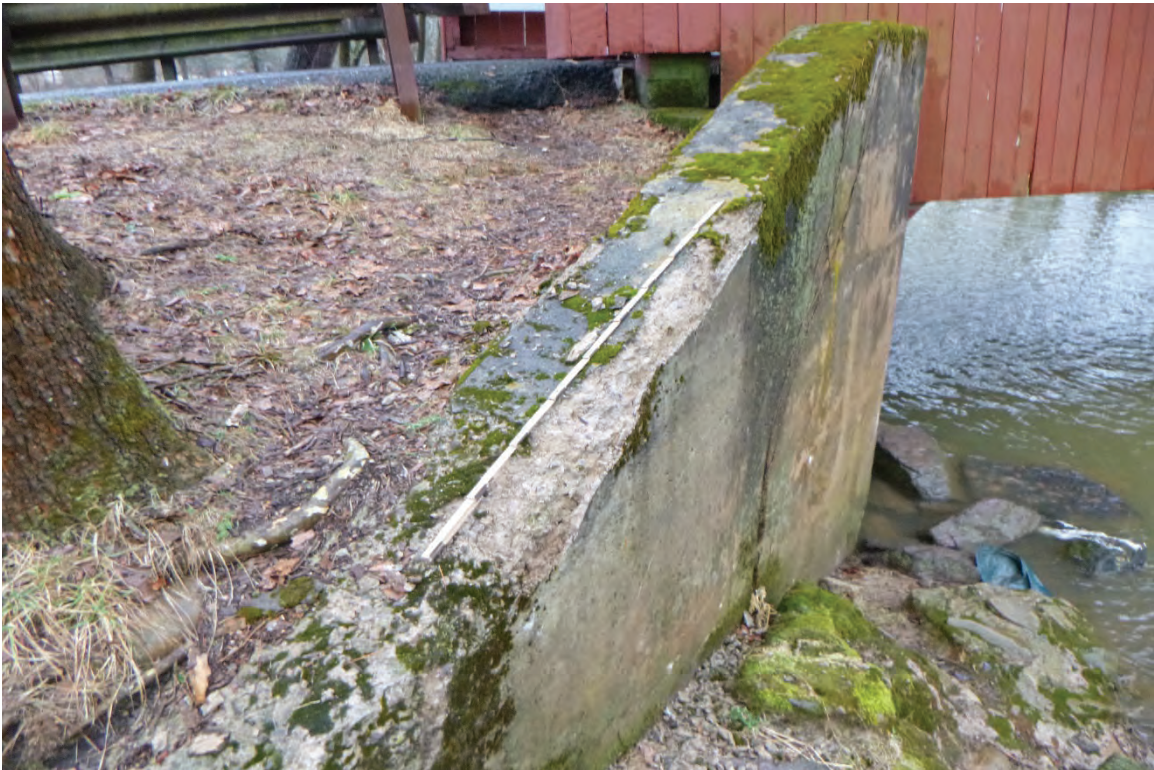
FAR LEFT WINGWALL

Note: Deteriorated concrete.

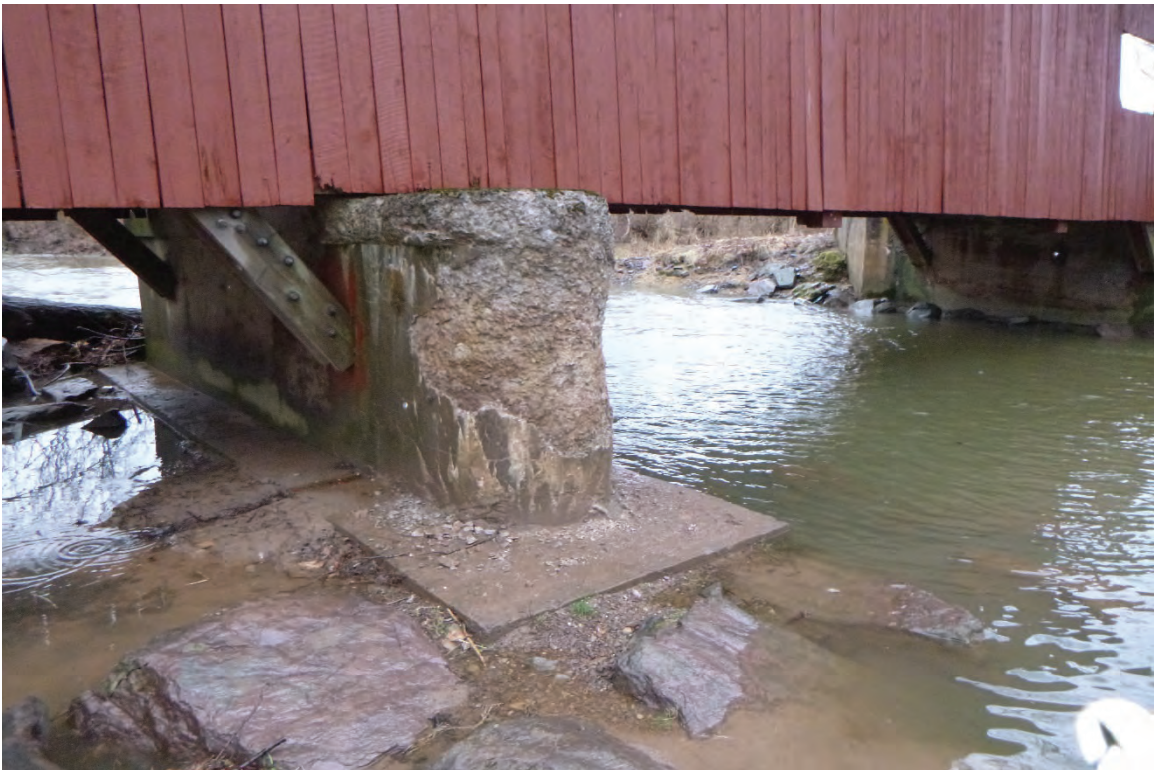
The concrete pier cap exhibits a full height concrete deterioration that extends into the pier stem. The deterioration extends around the downstream end of the pier with hairline to open cracks with efflorescence. There is deterioration on the downstream end of the pier stem. The deterioration is active and will continue to increase. There is also unsound concrete on the downstream half of the pier.

DETERIORATION OF DOWNSTREAM END OF PIER

Note: Active deterioration present with continual increase in deterioration.

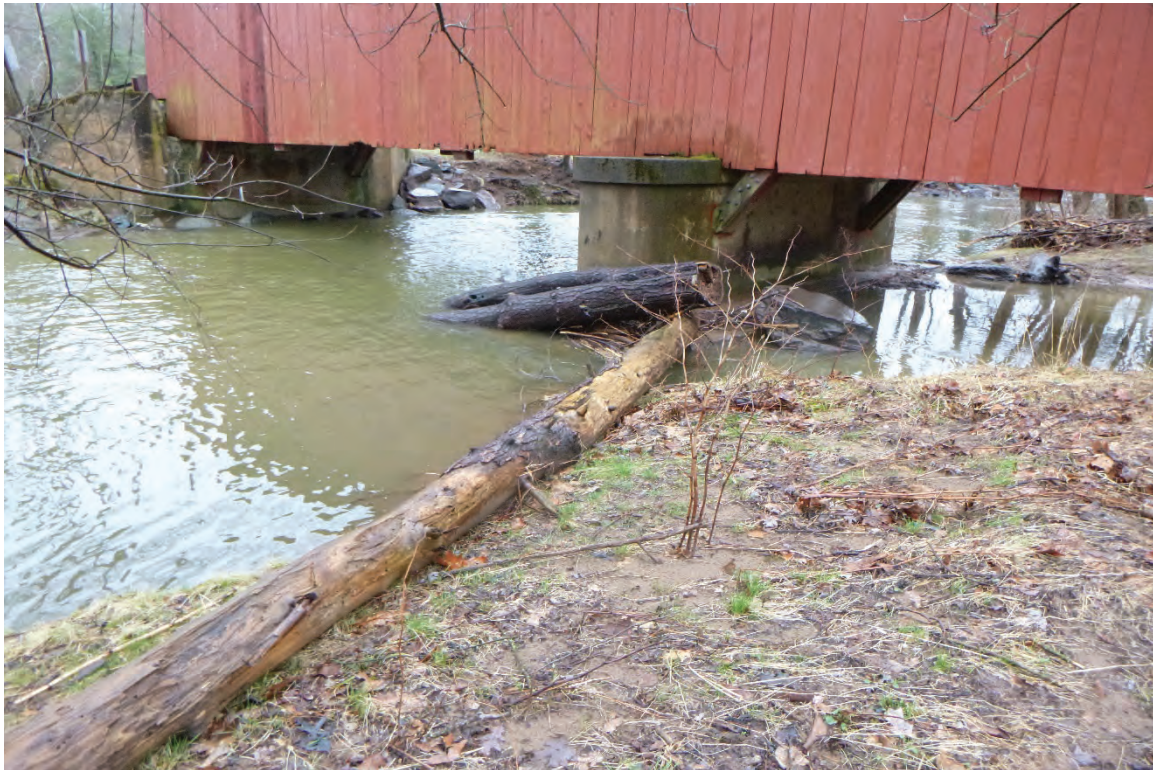
DEBRIS AT THE UPSTREAM NOSE OF THE PIER

Note: New since the 2020 inspection.
