## ***2021 ROUTINE BRIDGE SAFETY INSPECTION REPORT***

Cleveland Township, Columbia County  
T-356 (Shakespeare Road) over Roaring Creek  
County Bridge No. 12  
BMS No. 19-7205-0356-0012  
BRKEY: 12785

March 24, 2021  
C1  
12 Months  
Dale J. Sitler, P.E., C.B.S.I.  
and  
Andrew J. Susen, C.B.S.I.

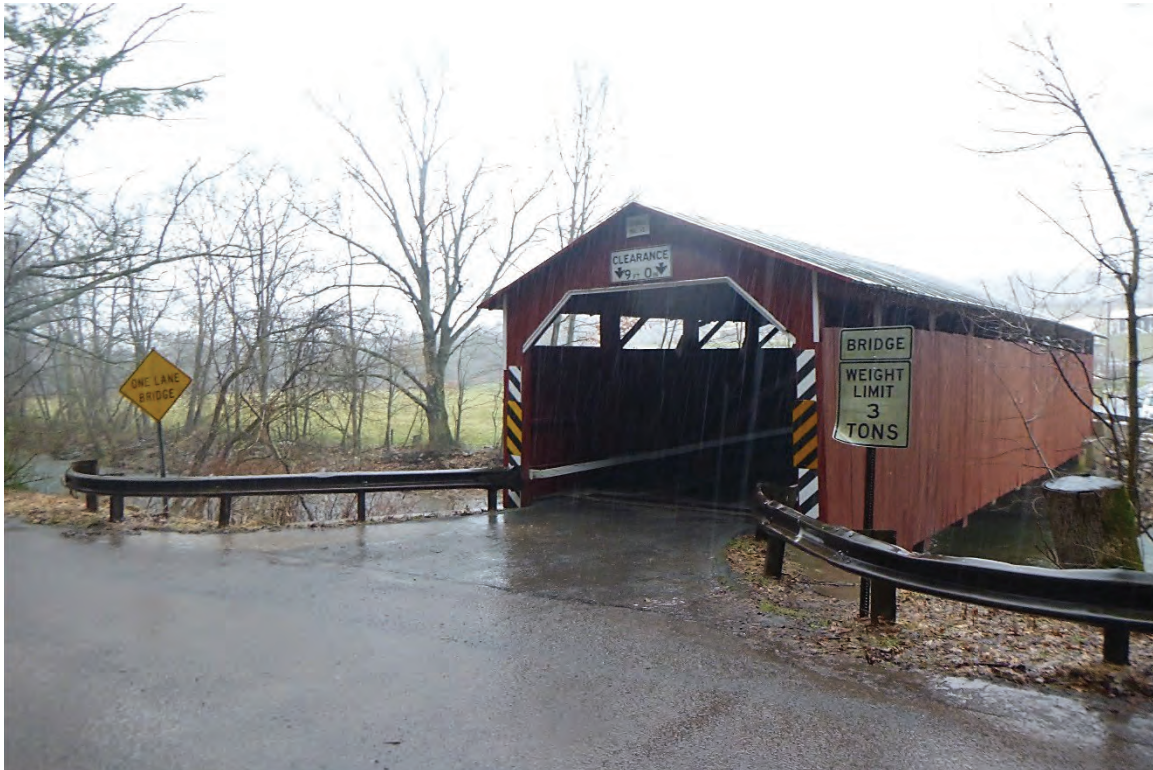
NEAR APPROACH

The near bituminous approach roadway exhibits minor gravel deposits. There is 2 1/2" of maximum settlement along the near backwall. The bituminous exhibits minor wear with shallow depressions. The far approach exhibits 1 1/4" of maximum settlement along the backwall and a full width open transverse joint approximately 10' from the structure.

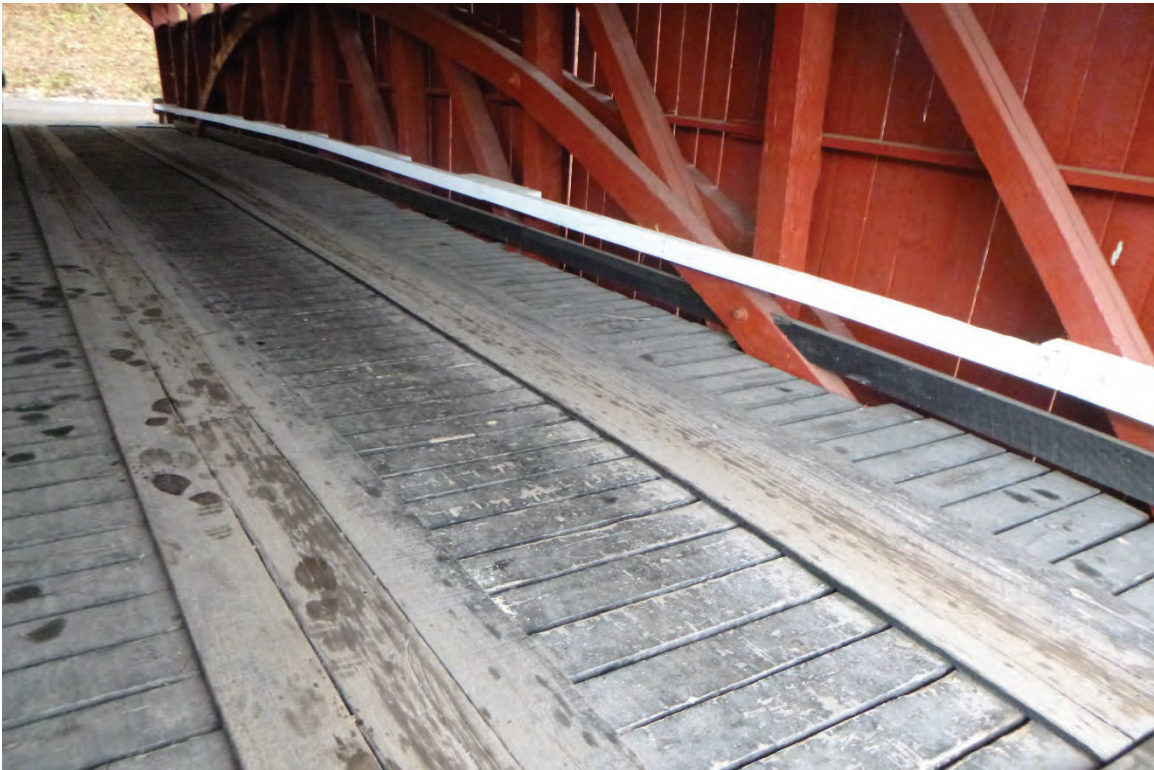
GENERAL VIEW OF BRIDGE WEARING SURFACE AND RAILING

The deck wearing surface consists of longitudinal timber running boards with asphalt coating. The running boards exhibit minor checks and splits and up to a 1/4" elevation difference at the joints. There is moderate wear of the surface of the timber resulting in minor protruding nail heads. There are isolated open checks and random wide splits in the boards especially at the board ends. There is very minor decay at the near end of the right running board; the board remains secure. The center board at the near end of the right wheel path is not attached to the deck. The board is confined by the adjacent boards and does not present a threat to the traveling public. All the other boards remain secure. There are several newer boards along the deck. Approximately 90% of the asphalt coating is worn off.

The transverse timber plank deck is coated with asphalt and exhibits minor checks and splits, and up to 2" gaps between the planks. There are areas of missing asphalt. There are also a few isolated heavy splits at the ends of the boards outside of the travel way, especially at the near right. There is an isolated 2" wide decay hole through the deck board to the right of the running boards near mid-span. The underside of the deck exhibits minor checks and splits.

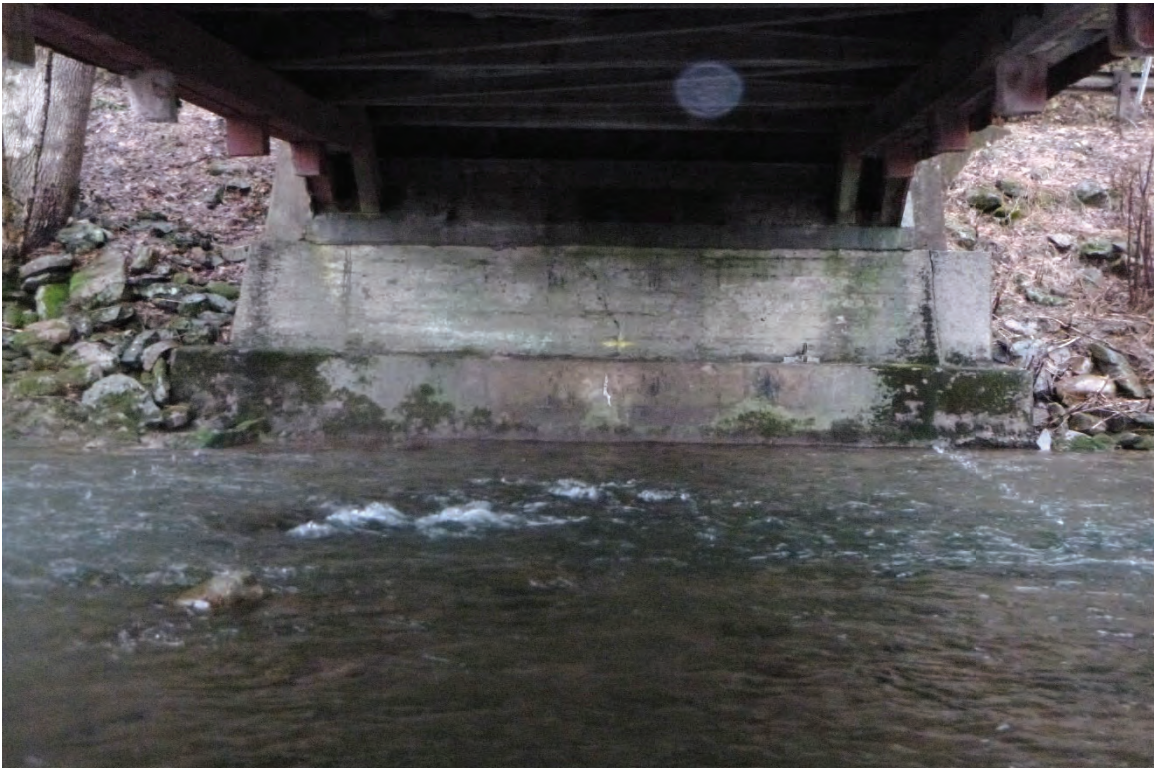
NEAR ABUTMENT

The stone masonry abutment stems exhibit a two-tier full-height concrete encasement. The original stone masonry abutment is not visible. The top tier of the near abutment concrete encasement exhibits moderate scaling, isolated areas of unsound concrete and a few full height vertical cracks. There are vertical cracks in construction joints at the left and right ends of the abutment at the top of the abutment. There is also a full height vertical crack near the center of the stem that has not increased since the last inspection. The bottom tier exhibits moderate deterioration at the bottom left corner and a few full height vertical hairline cracks that extend into the top tier.

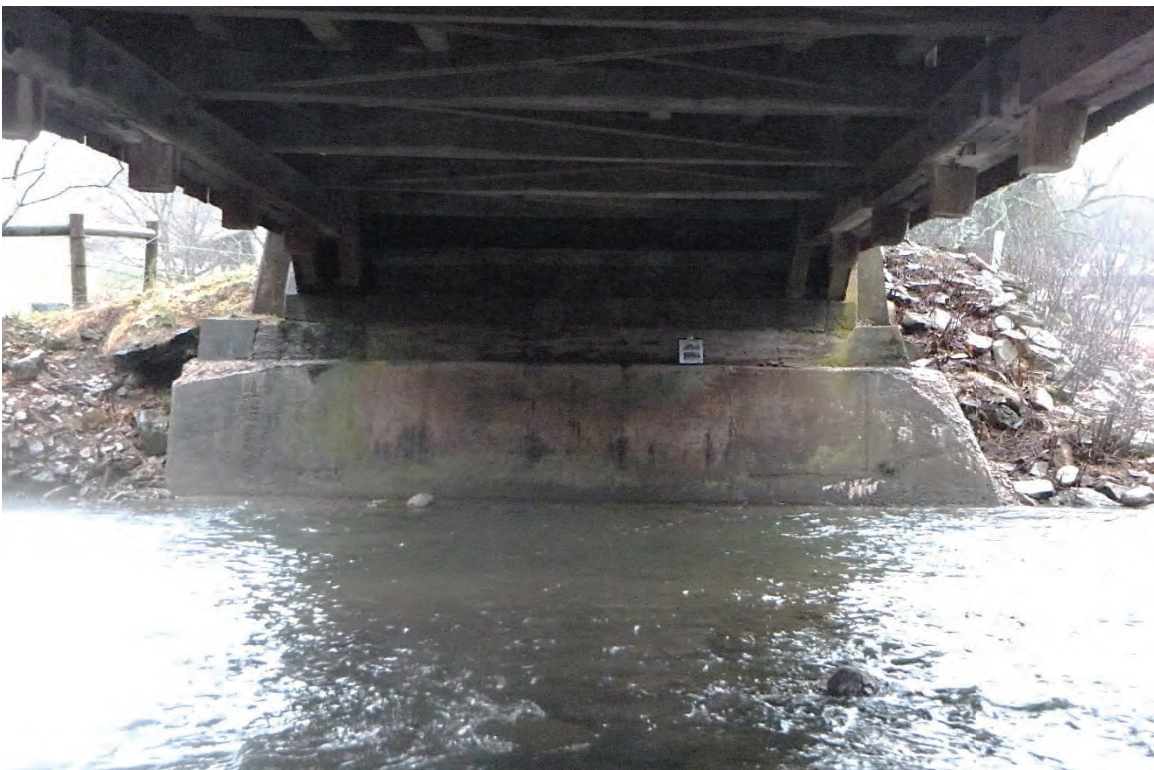
FAR ABUTMENT

The top tier of the concrete encasement on the far abutment exhibits moderate scaling in the older portions with light scaling at the waterline, areas of unsound concrete, and a full height vertical crack at the left end with edge spalling. The bottom tier exhibits moderate deterioration, areas of unsound concrete, and horizontal and vertical hairline cracks with moderate efflorescence. There is concrete deterioration at both corners that has increased slightly since the 2017 inspection. The deterioration at the left corner is active with adjacent unsound concrete. There is a full height hairline vertical crack adjacent to the right bottom chord and below Stringer 2.

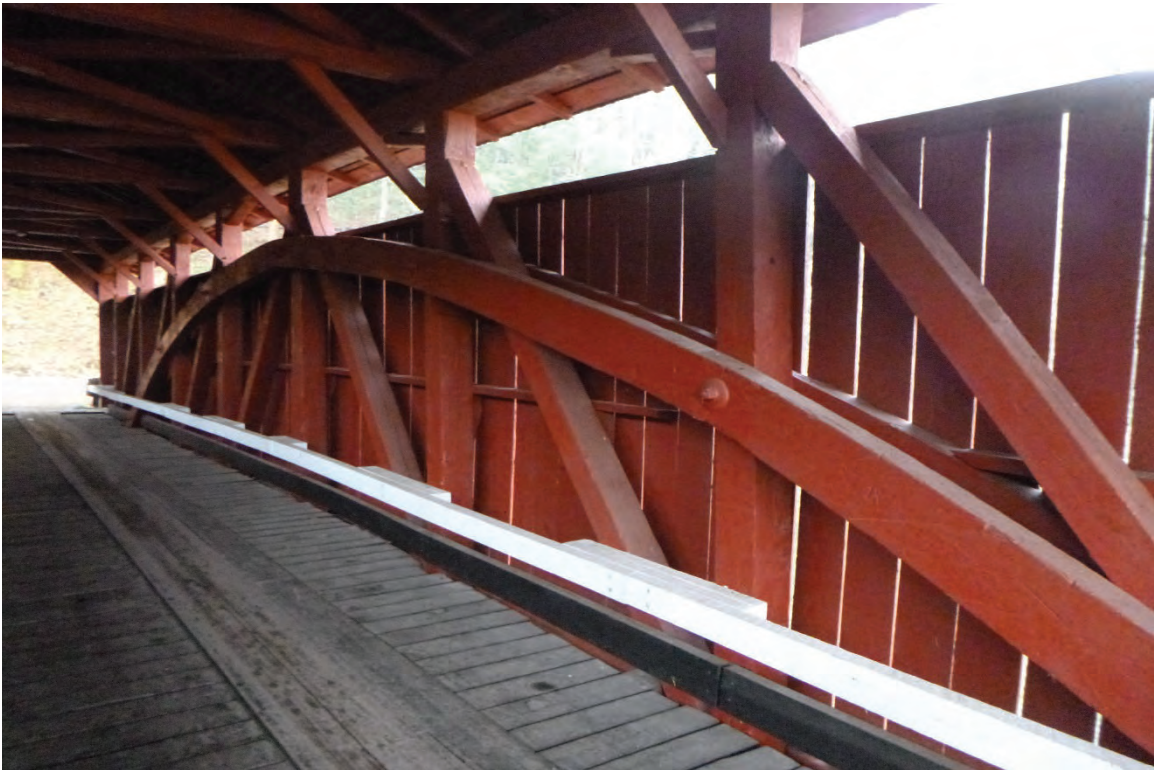
GENERAL VIEW OF TRUSS

The timber truss members exhibit minor to moderate checks and splits throughout, minor surface decay, and areas of minor insect damage. The upper chord joints are sound. Member U5U6 at the right truss is twisted out of plane by 1/2" at the splice. Member L0U1 on the right truss is newer with 1/8" checks and 3/4" awl penetration. There are splits starting in several of the verticals at the top diagonal connections with the worst at U5 right with 3/16" wide split through the vertical above the notch. The verticals at L4 left and right and L5 on the left exhibit moderate splits below the low chord. Member L0U0 and L8U8 at the left and right truss have been previously replaced and spliced into existing vertical members. L0U0 right exhibits a 1/8" wide check at splice with 11/16" awl penetration. Member L2U2 on the right was repaired due to damage from the 2011 flood. There is minor decay at the lower truss diagonal member connection to L5U5 on the left truss with section loss due to the decay. There was no change in the decay since 2016. There is also an area of decay at the connection of member L6U6 and member U5L6 at the right truss with decay in both members. The ends of the verticals below the lower chords exhibit moderate surface decay and collision damage from high water debris. The diagonals exhibit checking up to 3/8" wide and 2" awl penetration. There is 1/8" separation of the lap splice at the far right and far left corners. There are 1/2" gaps at the upper chord to vertical connection at U5 and U8 on the left.

The original lower chords exhibit minor surface decay and minor insect infestation. The newer lower chords are spliced into the existing members. The splices are secure with slight misalignment between Vertical 3 and 4 on the left. The members were repaired due to the September 2011 flood.

The original arch members exhibit minor checks, splits and isolated minor surface decay. The top of the interior arch at the far right has a decay behind the curb with no increase in decay since the 2016 inspection. The interior arches above the deck also have minor scrapes due to collisions. There are newer arch members spliced into the existing members. The splices are sound. The newer arch and low chord members are CCA treated.

Note: Right truss shown.

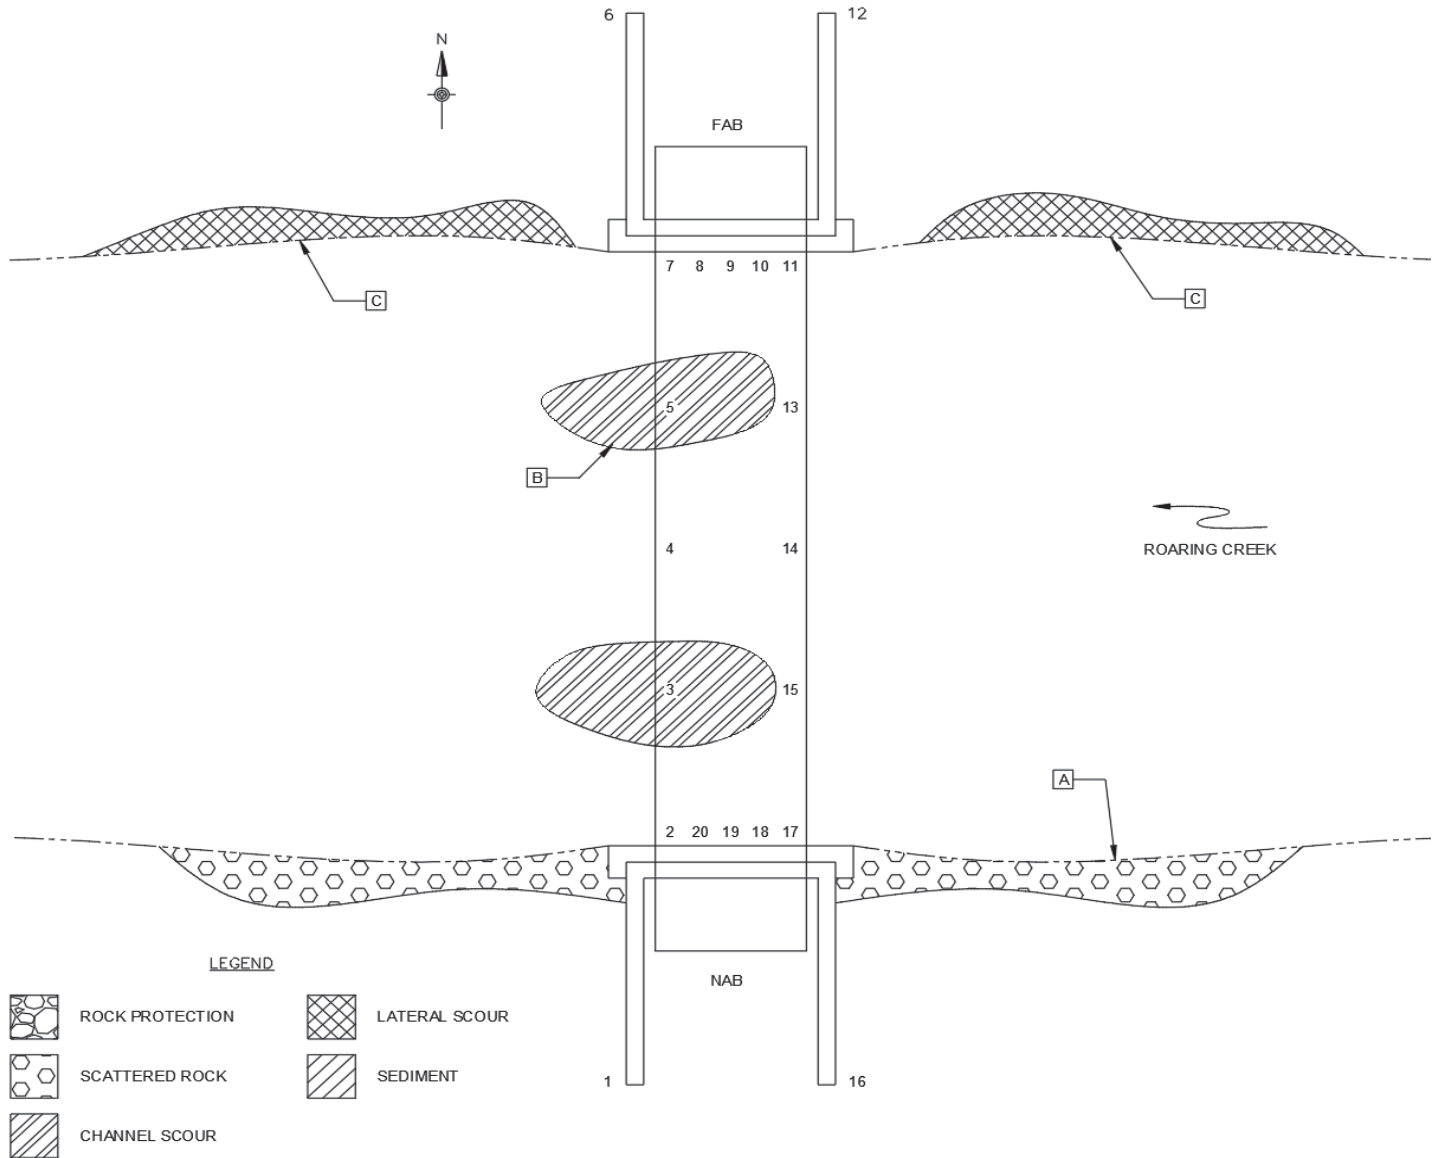
Bridge Site Map

- A Large natural rock
- B Channel Scour - Minor
- C Lateral Scour - Minor
