2021 ROUTINE BRIDGE SAFETY INSPECTION REPORT

Cleveland Township, Columbia County
T-373 (Esther Furnace Road) over Roaring Creek
County Bridge No. 11
BMS No. 19-7205-0373-0011
BRKEY: 12786

March 24, 2021
C1
12 Months
Dale J. Sitler, P.E., C.B.S.I.
and
Andrew J. Susen, C.B.S.I.

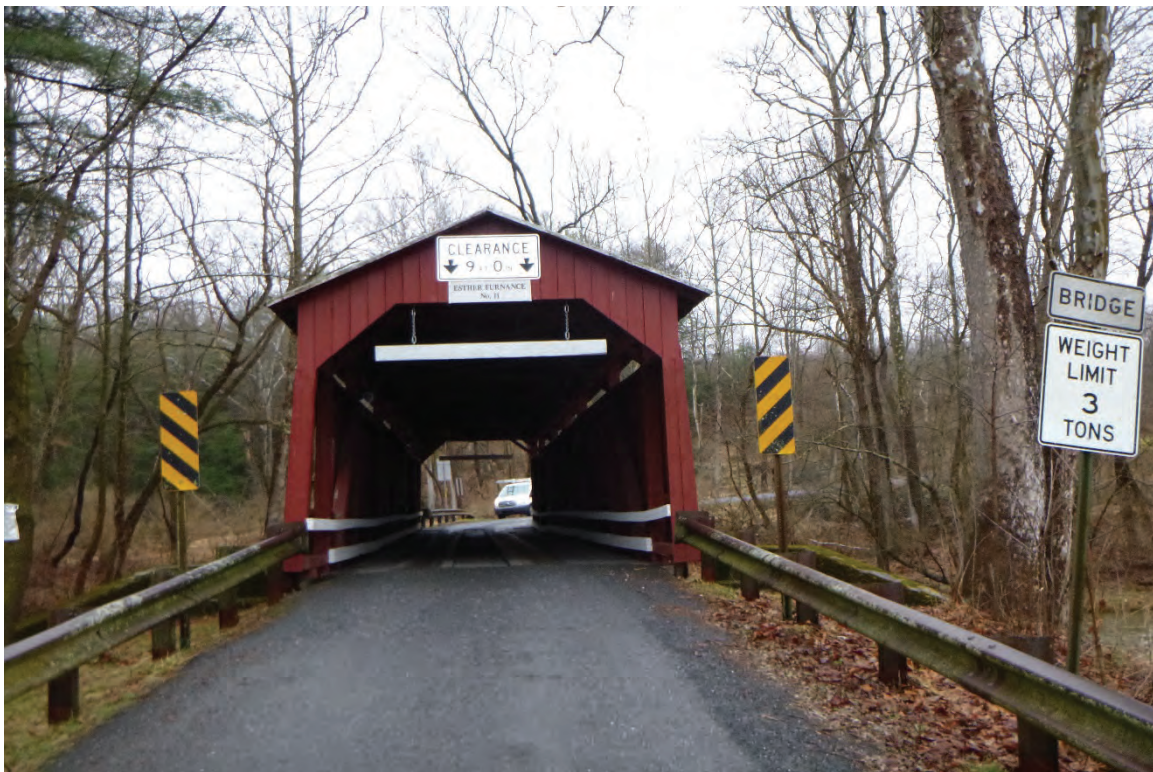
NEAR APPROACH

Note: Near Bridge Load Posting is covered with dirt. Remains legible.

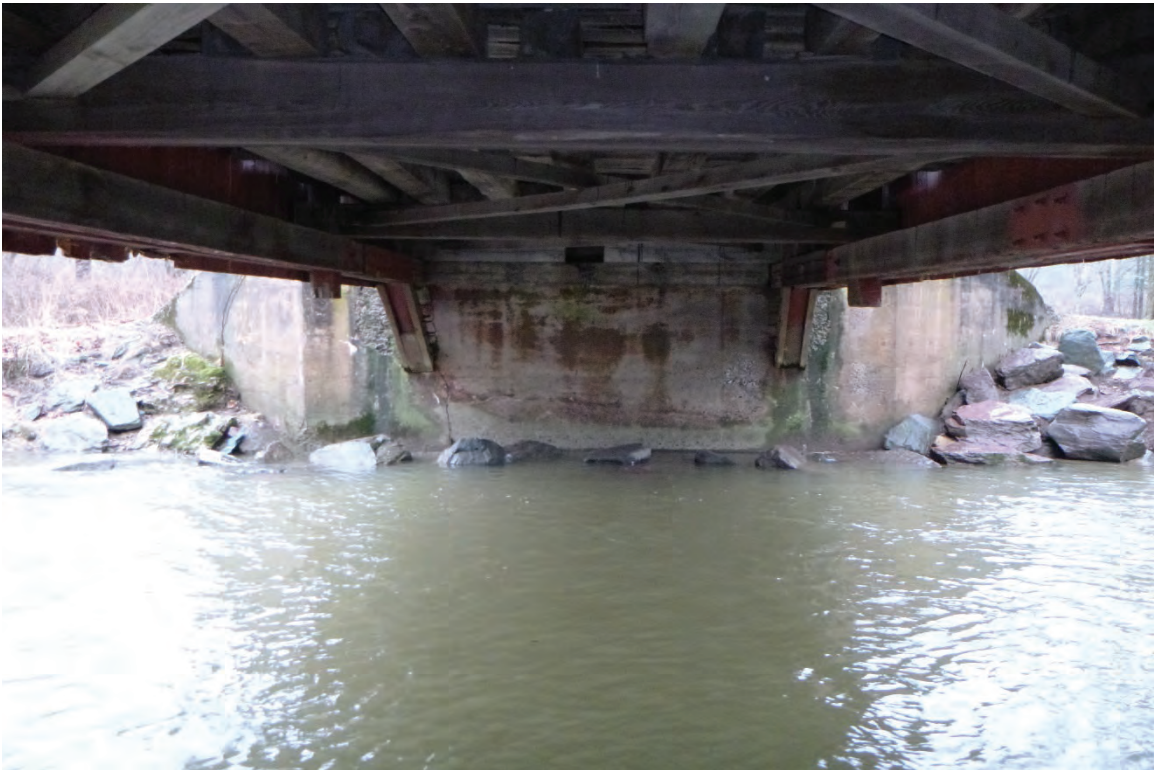
TYPICAL VIEW OF PIER

The concrete pier cap exhibits a full height concrete deterioration that extends into the pier stem. The deterioration extends around the downstream end of the pier with hairline to open cracks with efflorescence. There is deterioration on the downstream end of the pier stem. The deterioration is active and will continue to increase. There is also unsound concrete on the downstream half of the pier.

The footings at both abutments are not exposed. The pier footing is exposed behind the large rock protection up to 2.0' high at the inlet end on the far side. The pier footing exhibits light scaling and minor surface edge spalls.

Note: Far side shown.

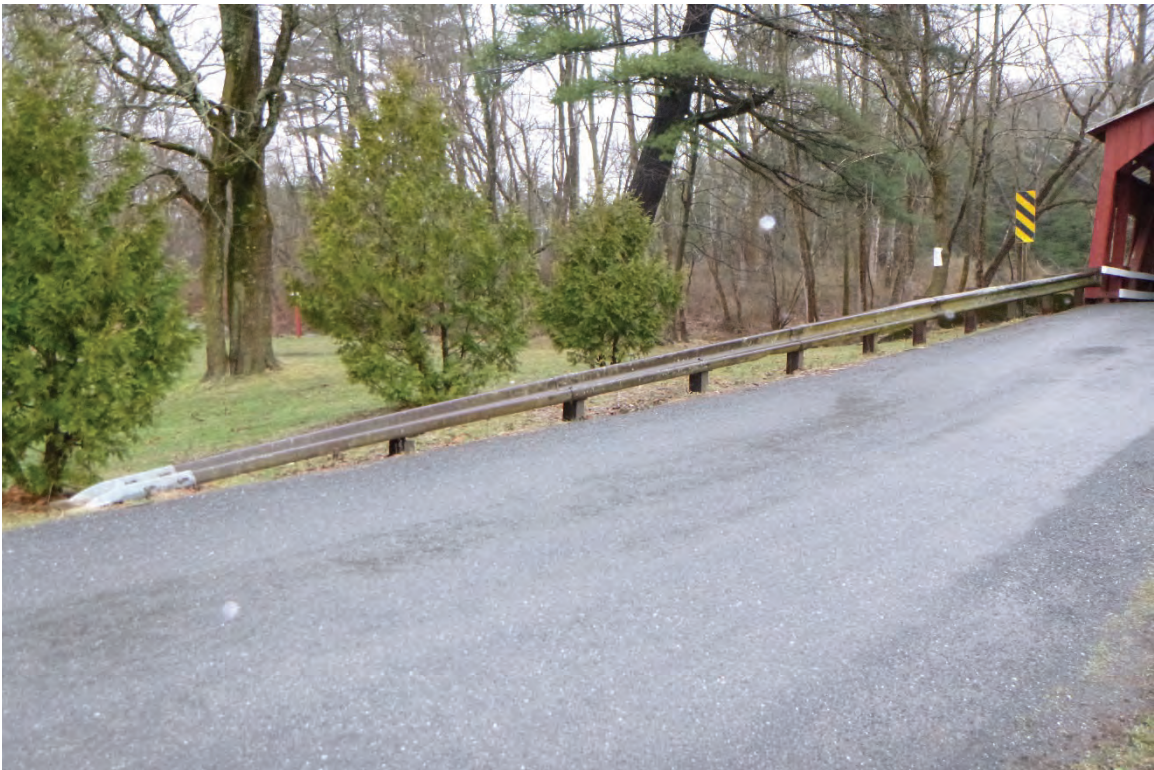
FAR ABUTMENT

The far concrete abutment stem exhibits light to moderate scaling along the bottom. A full height, 3/8" maximum width crack with 1/8" displacement extends from the left low chord seat through the truss seat to the ground, there was no change since the 2007 inspection. There are areas of unsound concrete and efflorescence adjacent to the crack and at the seats. There are also areas of delamination and efflorescence at the right lower chord and truss seats with areas of deterioration. There is hairline map cracking with minor efflorescence at the left end.

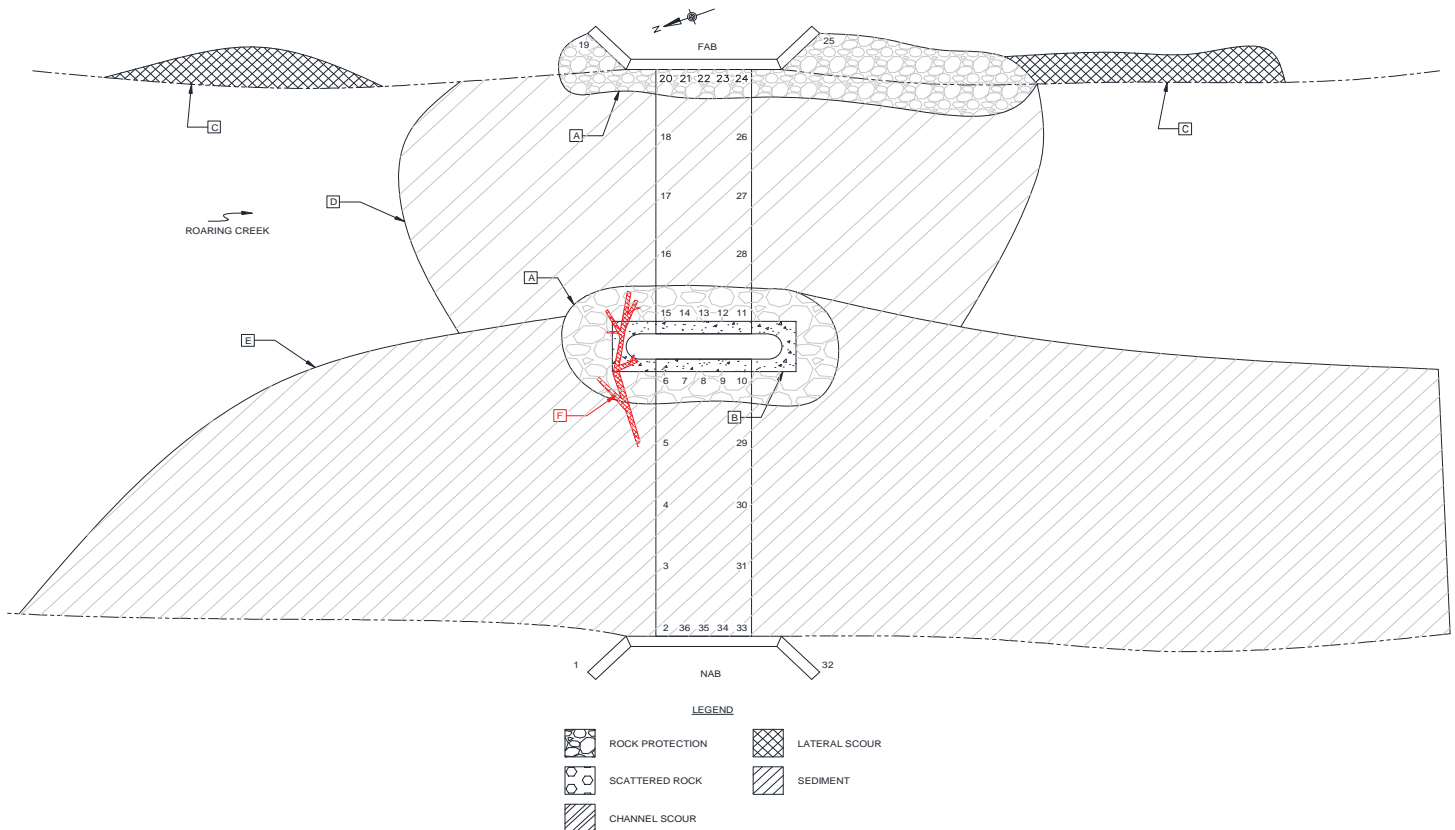
Bridge Site Map

- A Rock protection placed along the far abutment and at the pier after flood of 2006
- B Footing exposed behind large rock.
- C Moderate to heavy lateral scour with exposed tree roots. Not adjacent to the structure.
- D Scour hole upstream, downstream and through Span 2 of the structure in the channel.
- E Large, shallow sediment deposit extending up, under, and downstream of the structure with vegetation and trees. No removal required.
- F **Trees and brush lodged at the upstream nose of the pier**

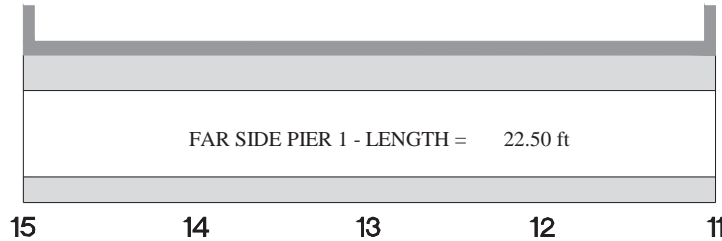
PIER TYPE: <u>Concrete</u>	REFERENCE POINT: <u>Varies as noted</u>
STREAMBED MAT'L: <u>A5</u>	MAX WATER DEPTH: <u>0.00 ft</u>
	UNDERMINE/SCOUR PRESENT: <u>Yes</u>

Location		15	14	13	12	11	
Reference Point Description		Low Chord	Beam 2	Beam 3	Beam 4	Low Chord	Gauge Depth is set measurement from reference point indicating max until scour occurs. Can vary due to difference in elevation of reference point (ie - superelevation)
Gauge Depth		7.50 ft	9.50 ft	9.50 ft	9.50 ft	7.50 ft	
Ref Point to Bottom of Ftg		Unknown	Unknown	Unknown	Unknown	Unknown	
INSP BY:	DATE:	MEASURED UNDERCLEARs FROM REFERENCE POINT TO STREAMBED					COMMENTS:
KGT/KAB	7/20/1995	8.7 ft				8.2 ft	BASELINE MEASUREMENTS
	Scour Depth	1.2 ft				0.7 ft	
DJS/AJS	3/24/2021	7.9 ft	8.9 ft	9.5 ft	9.3 ft	7.3 ft	
	Scour Depth	0.4 ft	0.0 ft	0.0 ft	0.0 ft	0.0 ft	
SBJ/KMA	4/1/2020	8.0 ft	9.4 ft	9.4 ft	9.5 ft	7.8 ft	
	Scour Depth	0.5 ft	0.0 ft	0.0 ft	0.0 ft	0.3 ft	
DJS/ATR	3/18/2019	8.0 ft	9.5 ft	9.3 ft	9.5 ft	7.8 ft	
	Scour Depth	0.5 ft	0.0 ft	0.0 ft	0.0 ft	0.3 ft	
SBJ/ATR	3/26/2018	8.1 ft	8.8 ft	9.4 ft	9.2 ft	7.7 ft

Scour Depth	0.6 ft	0.0 ft	0.0 ft	0.0 ft	0.2 ft	
ATR/MDD	7/25/2017						Flood inspection; blank values indicate unable to measure due to high fast water
	Scour Depth						
DJS/JWL	3/7/2017	7.5 ft	9.1 ft	9.4 ft	9.3 ft	7.3 ft	
	Scour Depth	0.0 ft	0.0 ft	0.0 ft	0.0 ft	0.0 ft	
RDT/SBJ	3/8/2016	7.0 ft	8.8 ft	9.0 ft	9.0 ft	7.3 ft	
	Scour Depth	0.0 ft	0.0 ft	0.0 ft	0.0 ft	0.0 ft
